Lake LeAnn Shoreline Management Plan

Lake LeAnn Property Owners Association
Hillsdale County, MI

December 2, 2020

Project: 2004639

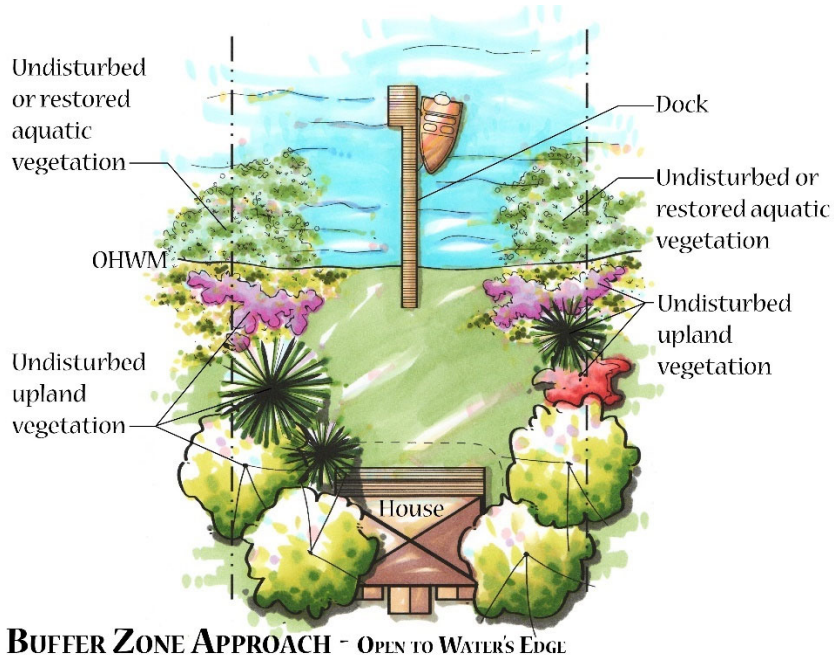
Sample natural shoreline layout. Source: MNSP

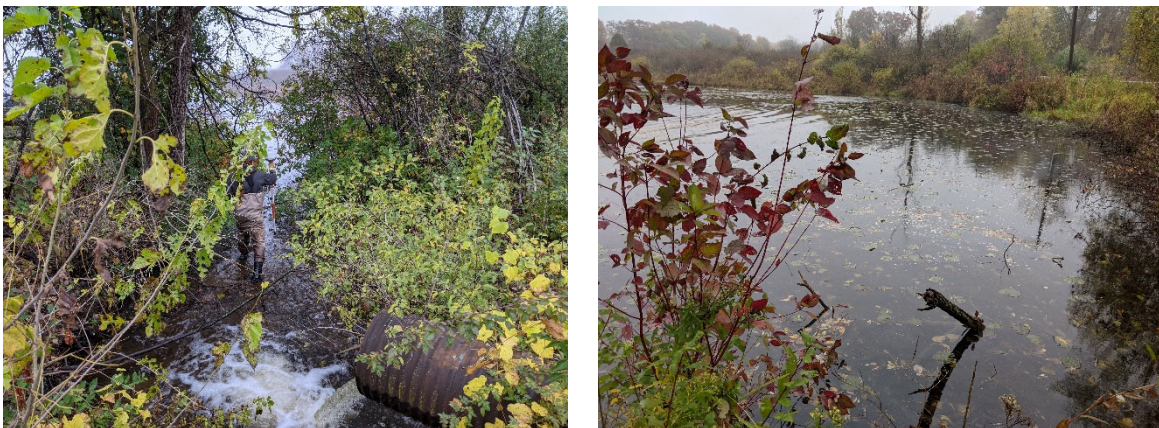
Outlet culvert of CSA 1a (left) and area around CSA 1b (right) with tiered vegetation.

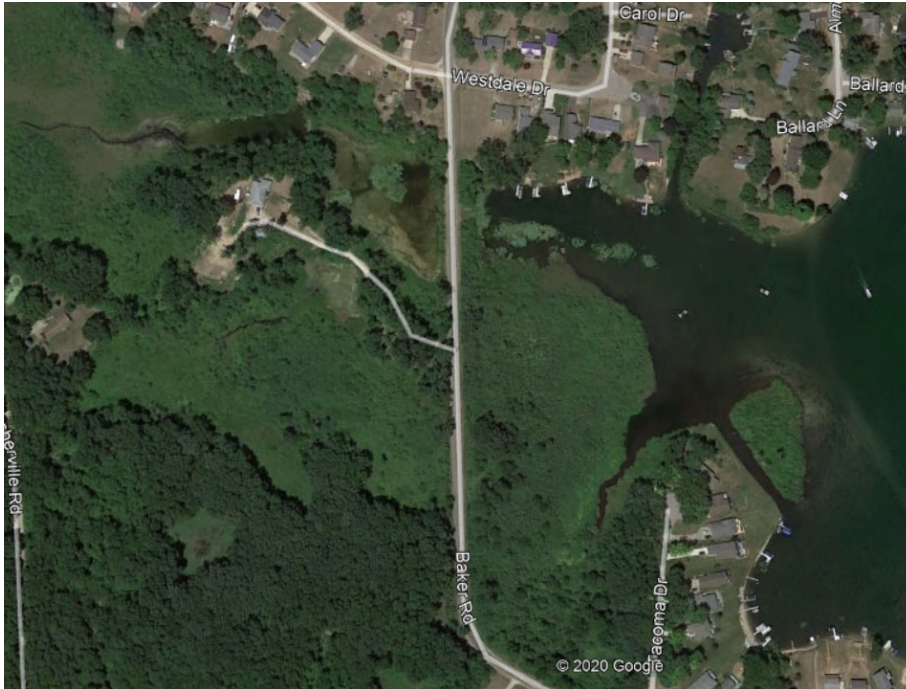
Figure 2. Wetland complexes on the west and east side of CSA1

CSA 1, subdivided into CSA 1a to the north and 1b to the south where two separate culverts enter the lake, is located on the east side of Baker Road and originates in a large wetland complex (approximately 31 acres) that drains into a pond prior to entering the culvert system. The areas around both culvert outlets in CSA 1 are well-vegetated with native wetland species, and the wetlands at the outlet of CSA 1a and 1b represent the largest wetland complex in the lake. Data gathered during previous site investigations has indicated that there are comparatively low levels of phosphorus entering the lake through CSA 1 (Figure 2).

Due to an already established wetland complex and low levels of reported phosphorous (Figures 2 and 3), no further actions at CSA 1 are recommended at this time. However, LLPOA will annually monitor the wetlands at the outlet of CSA

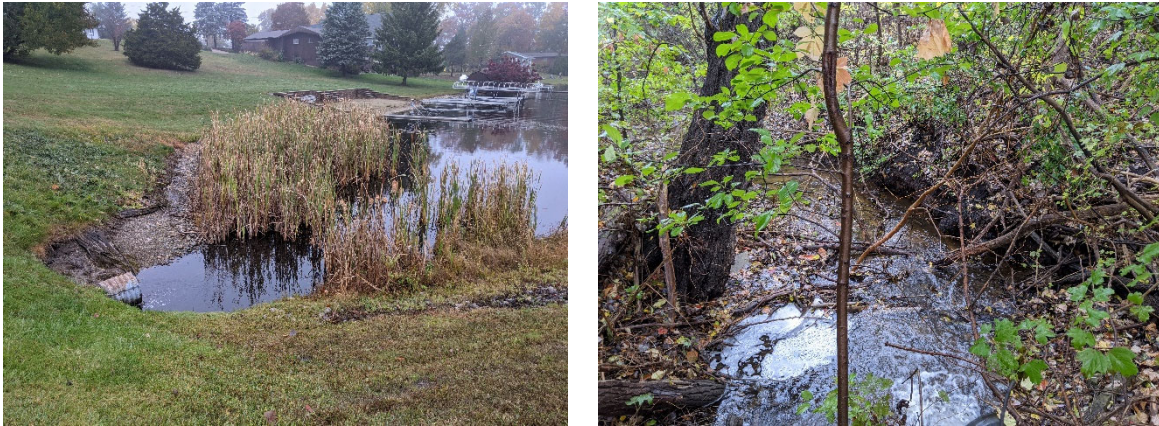
CSA 2 is located on the north side of Sauk Trail and includes two culverts; CSA 2a to the west and CSA 2b to the east. CSA 2a is framed by private property with an artificial beach to the west and mooring sites to the east. The shoreline is armored by cobbles and has cattails (*Typha spp.*) growing near the 16-inch corrugated metal culvert outlet. Sediment at CSA 2a is 100% muck and reaches a depth of approximately 3 ft. at the center of the inlet. CSA 2b is a wooded corridor to the west of CSA 2a with an elevated outlet culvert that empties into a stream. The streambanks immediately downstream of the culvert are experiencing significant erosion, particularly the right bank.

Outlet culvert of CSA 2a (left) and eroding stream bank of CSA 2b (right).

Proposed actions for CSA 2b are to stabilize the eroding streambanks with bioengineering by incorporating large woody material along the streambank (Appendix C). Proposed actions for CSA 2a include the installation of an approximately 6,200 s.f. native plant buffer along the east shoreline. This area includes the culvert outlet and extends northward to the mooring sites. Restoration activities include turf removal through the application of an aquatic approved herbicide followed by installation of erosion control blanket (100% biodegradable), and 2,708 native plugs planted at a spacing of 1-1.5 ft. on center (detailed plans provided in Appendix C).

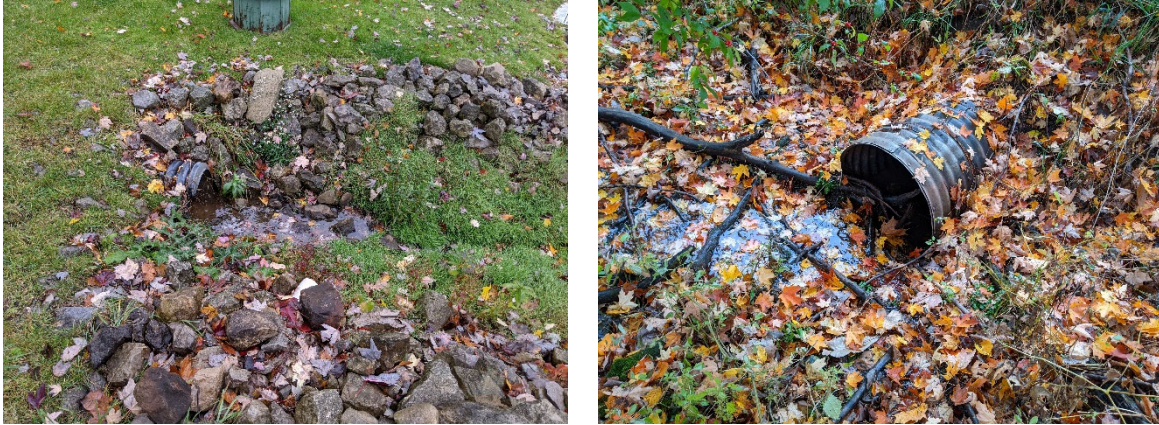
CSA 4 enters Lake LeAnn on the south side of Vicary Road with access off Greenbriar Drive. CSA 4 has two culverts; CSA 4a to the southwest and CSA 4b to the northeast. The outlet for CSA 4a is located on private property and heavily armored by riprap and cobblestone, for these reasons no actions are proposed at CSA 4a. On the north side of Vicary Road, CSA 4b travels along the east and south sides of a 10-acre cornfield before entering a 24-inch culvert under Vicary Road. Discharge from the culvert outlets through a wooded corridor into a wetland before reaching Lake LeAnn.

Outlet culvert of CSA 4a (left) and CSA 4b (right)

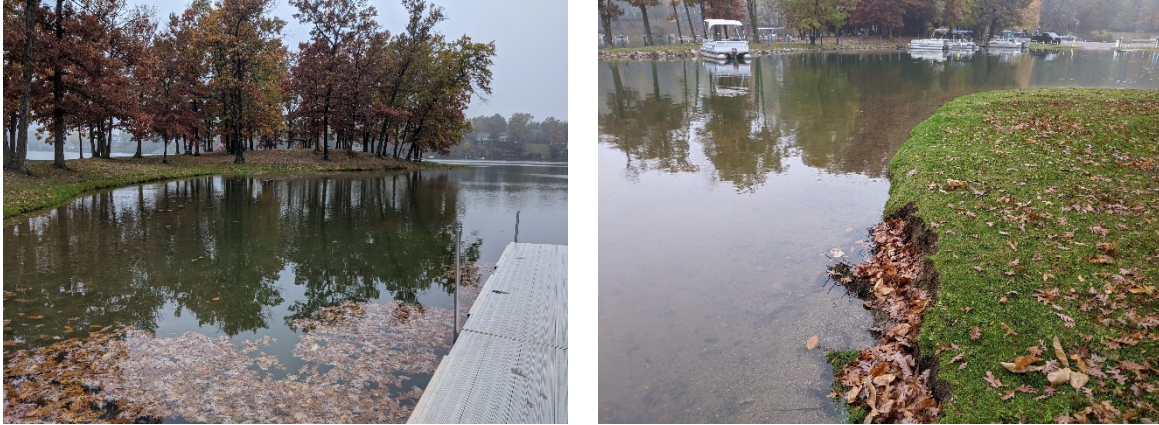
This proposed NSDA is located at the end of Dublin Court just west of the intersection of Bradley Dr. and Dublin Circle. There is a small inlet at the end of Dublin court that serves as a boat launch for the community and consists of a parking lot, mowed turf, park benches, and temporary docking structures. The eastern shore of the inlet is predominately riprap and is used as docking locations for lake residents. The western shore of the inlet is a soft shoreline with mowed turf to the water's edge under a canopy of mature oak (*Quercus spp.*). This area is primarily used as a public park.

Western shoreline of the North Boat Launch inlet (left) and eroding bank (right)

The north boat launch is a highly utilized public space and would be an ideal location for an NSDA. The western shore of the inlet is a soft shoreline and is already in a naturalized setting providing ideal conditions for ecological restoration. GEI proposes installing a 100 x 10 ft. native plant buffer beginning west of the boat launch and continuing north towards the tip of the peninsula where riprap begins (see Appendix C, DWG. NO. 4). Restoration activities include turf removal through the application of an aquatic approved herbicide followed by installation of 12 in. coir log at the shoreline and 1,000 native plugs planted at a spacing of 1 ft. on center. Upon completion of planting GEI will install a temporary wildlife barrier using hardwood stakes, biodegradable rope, and mylar flagging to reduce plant herbivory.

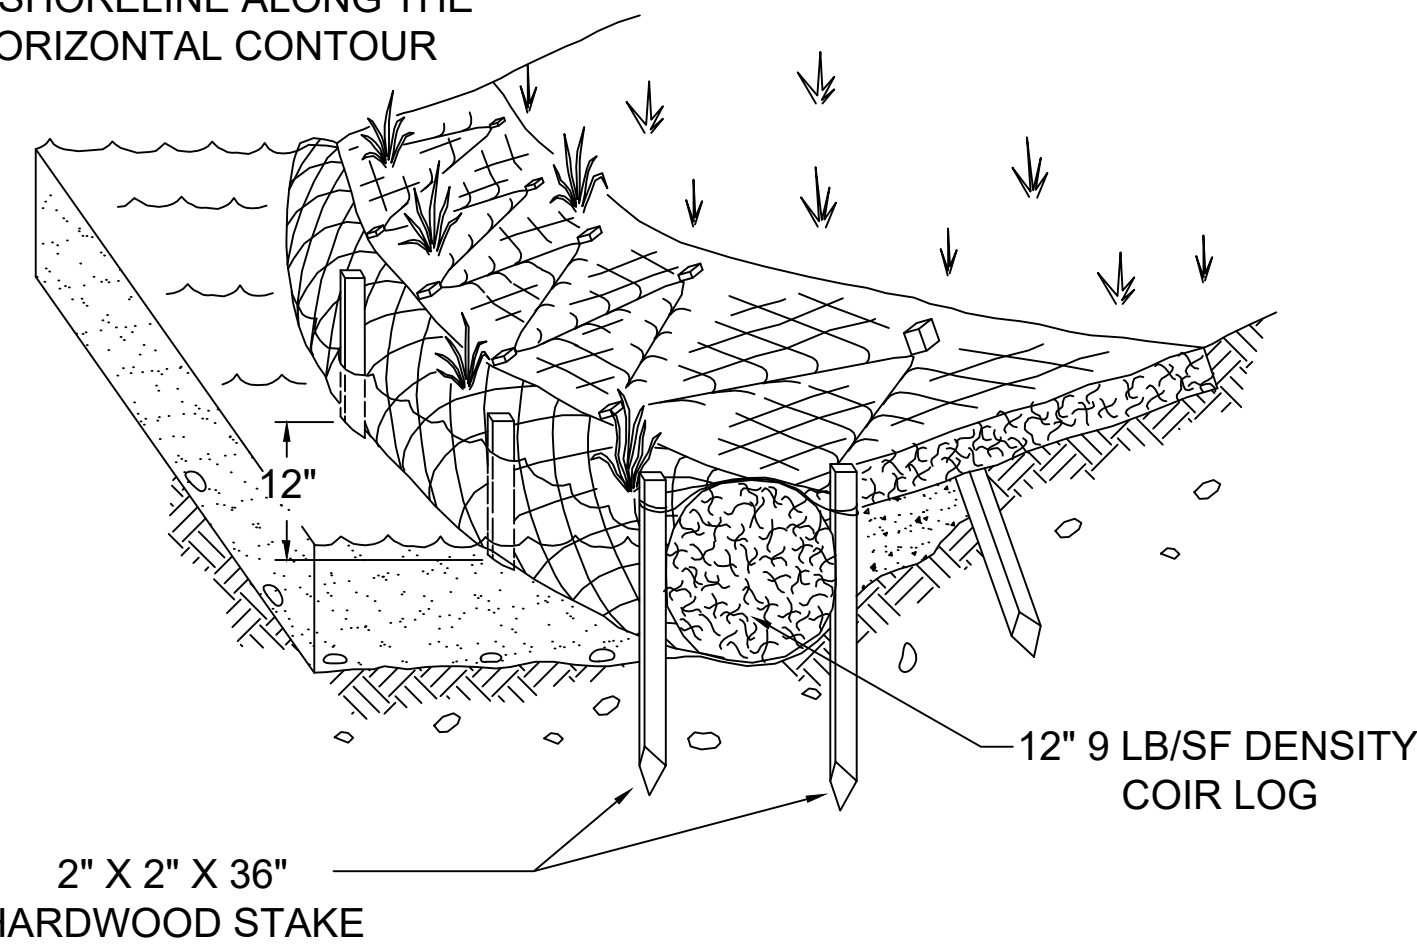
TYPICAL COIR LOG DETAIL
NOT TO SCALE

PLACE COIR LOGS PARALLEL TO SHORELINE ALONG THE HORIZONTAL CONTOUR

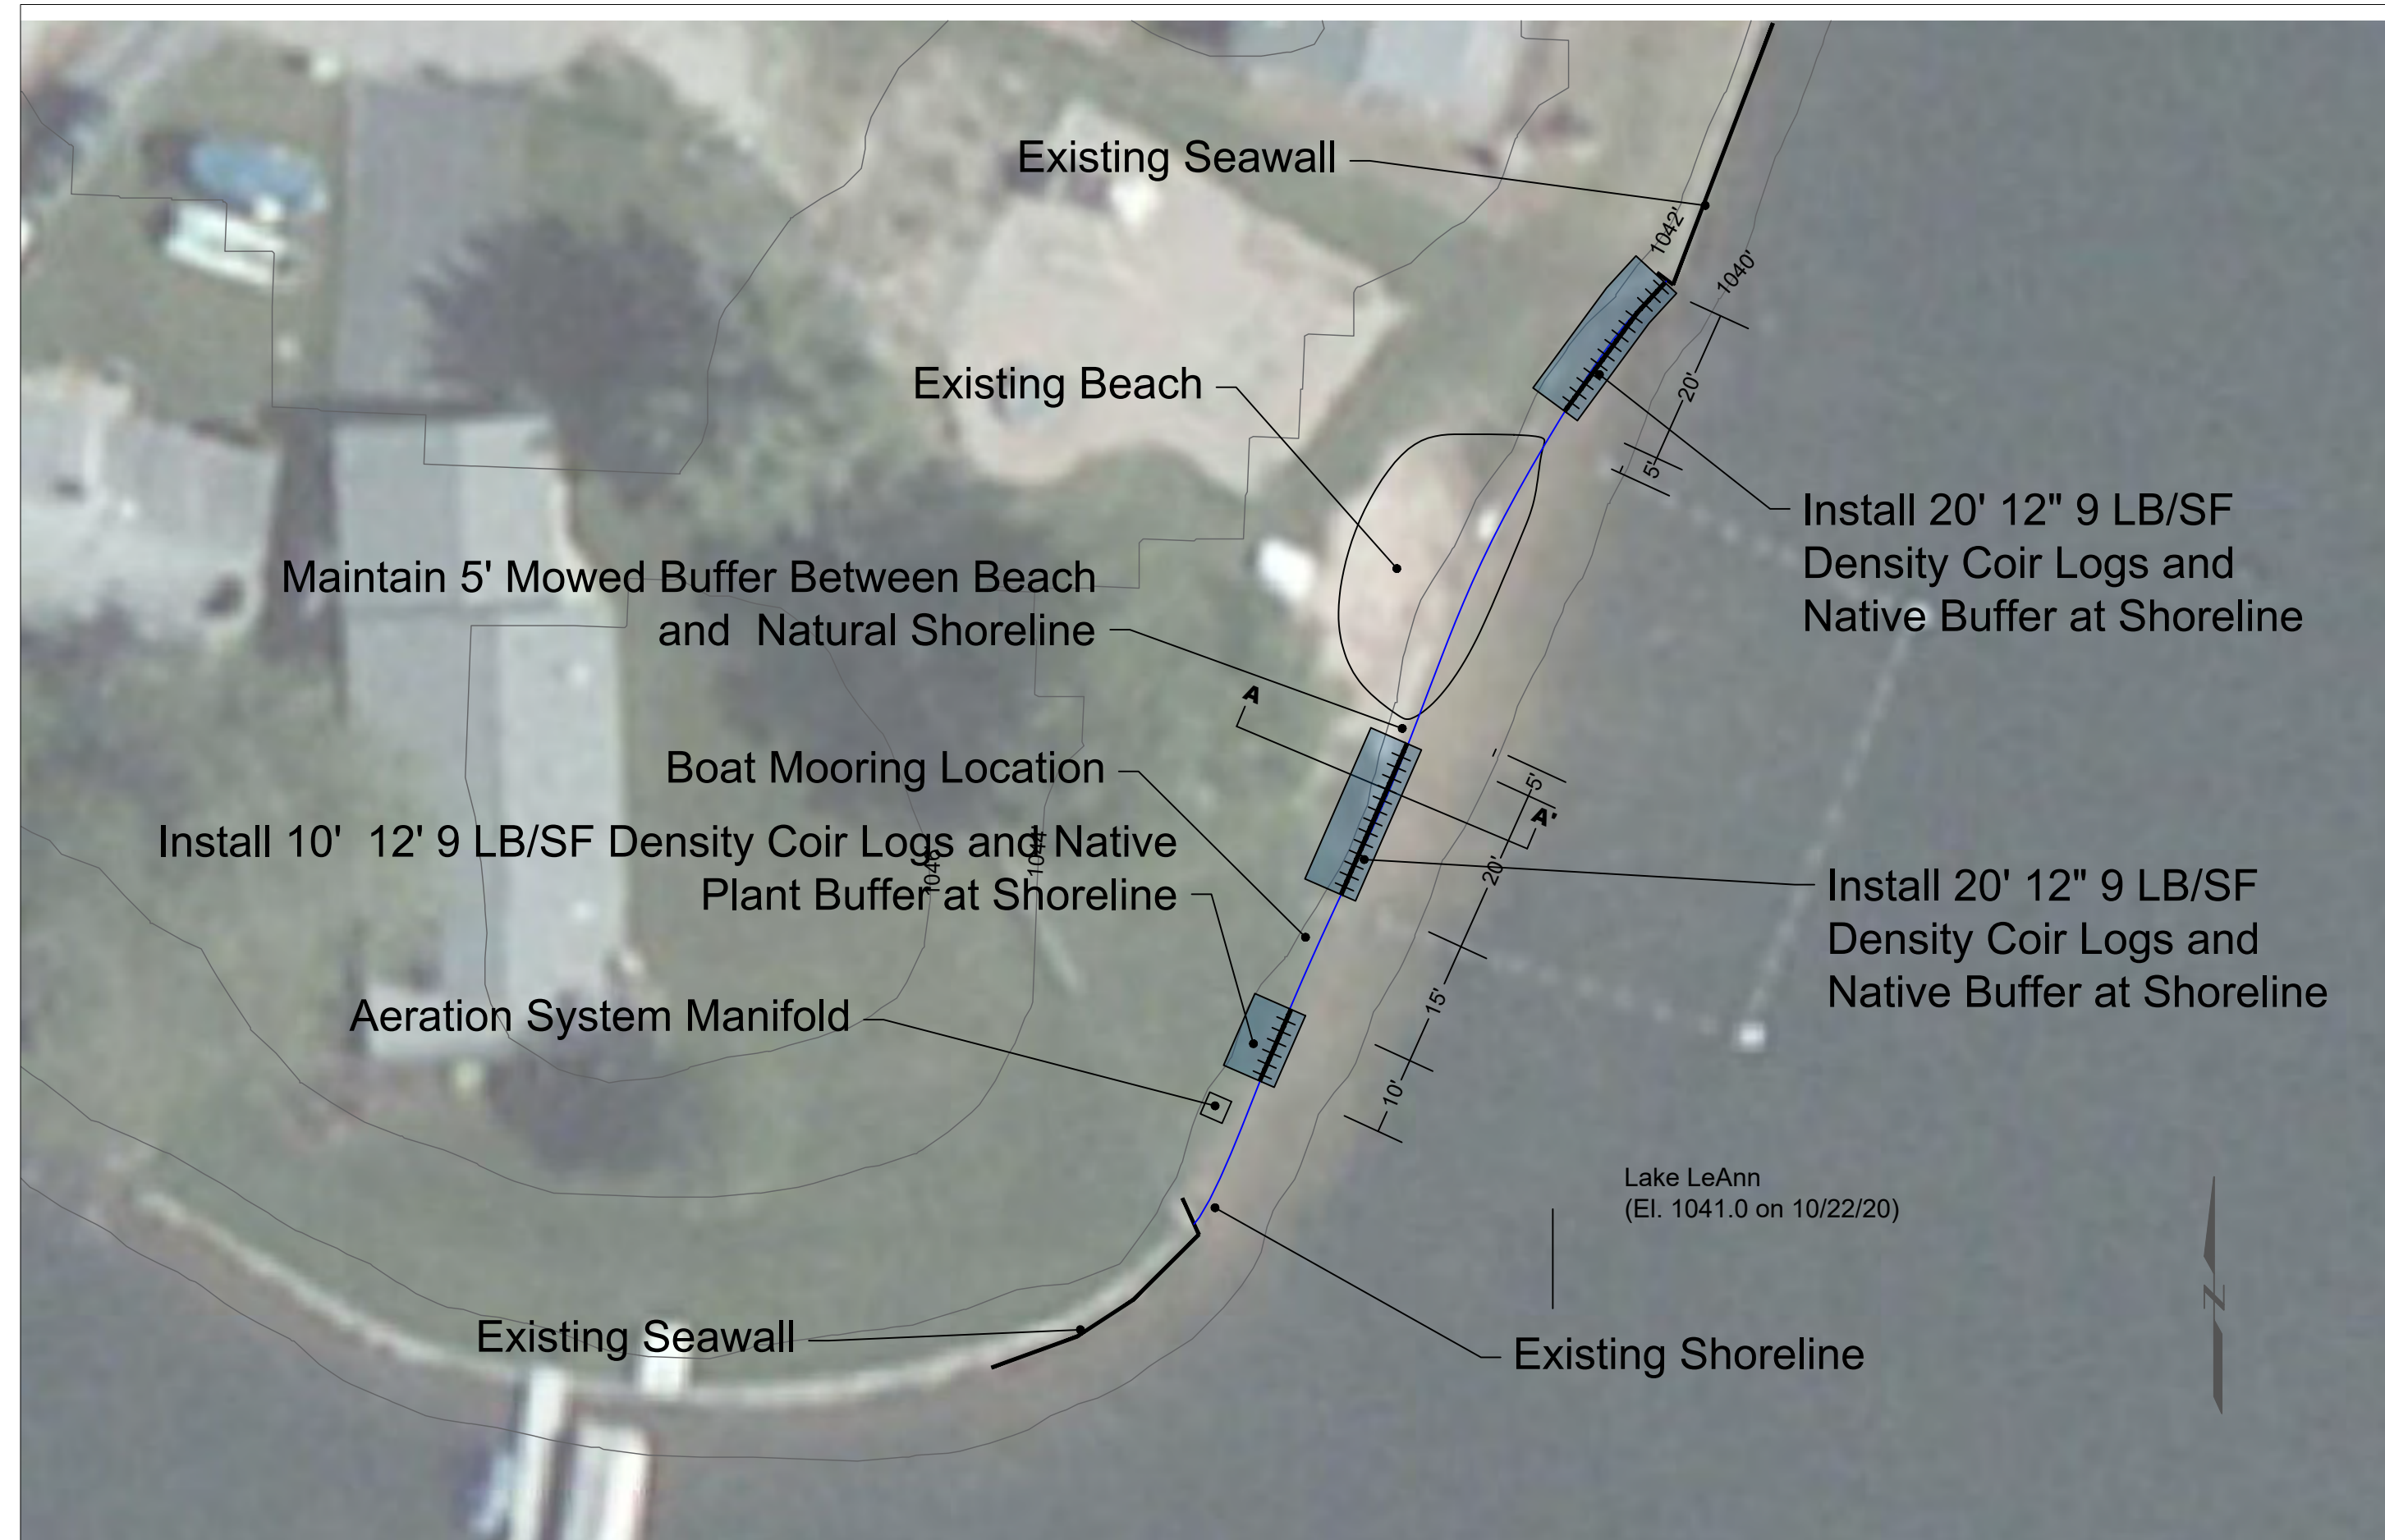
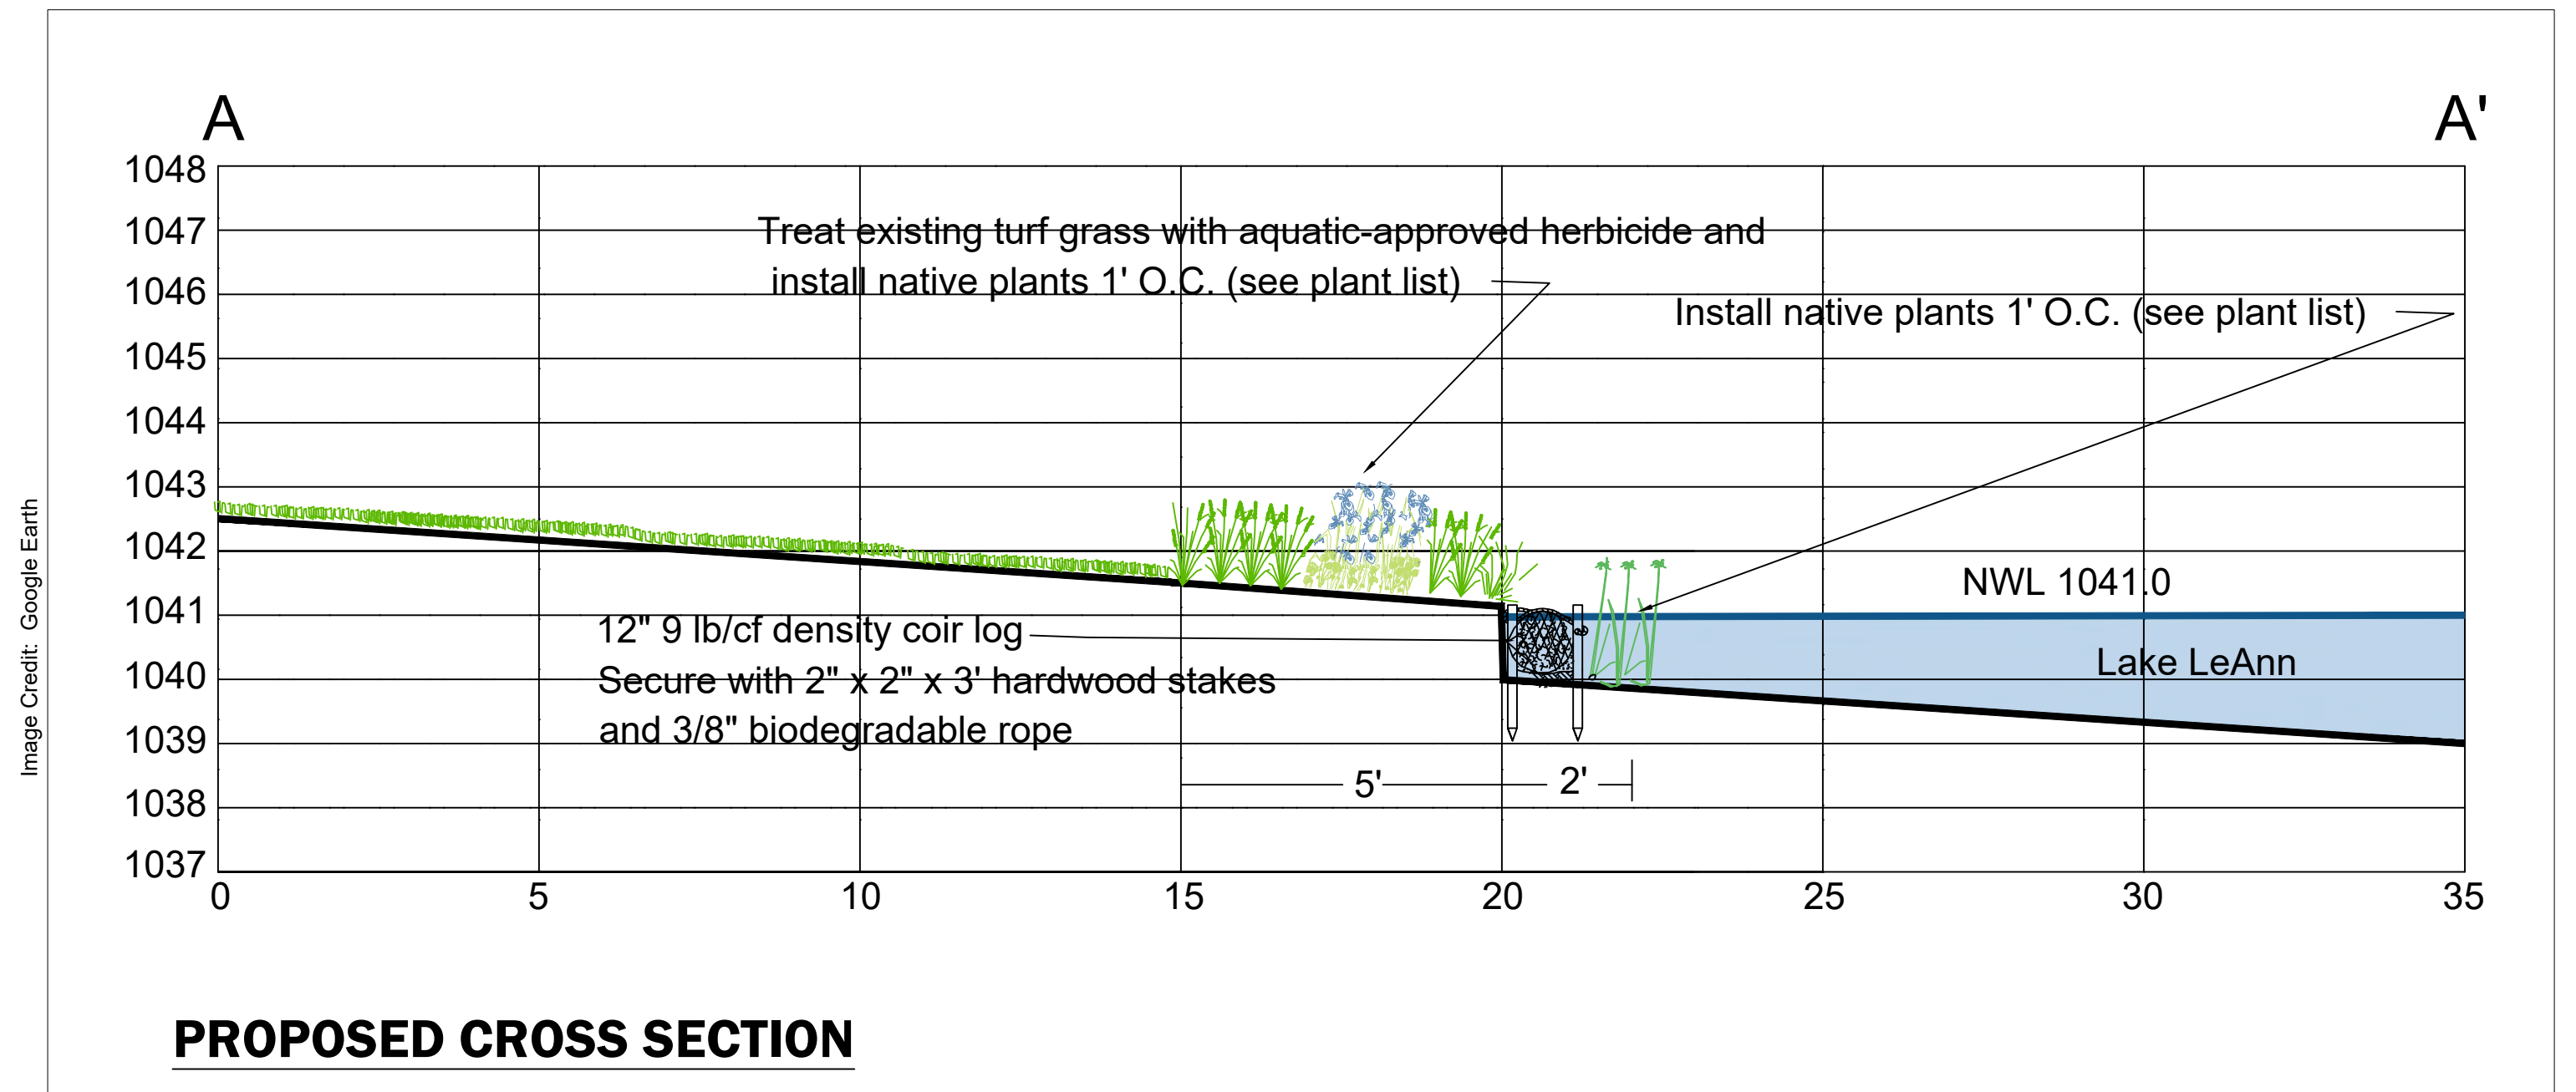
Lake LeAnn
Shoreline Management Plan
NORTH BOAT LAUNCH
SHORELINE DEMONSTRATION
SITE

PLAN VIEW

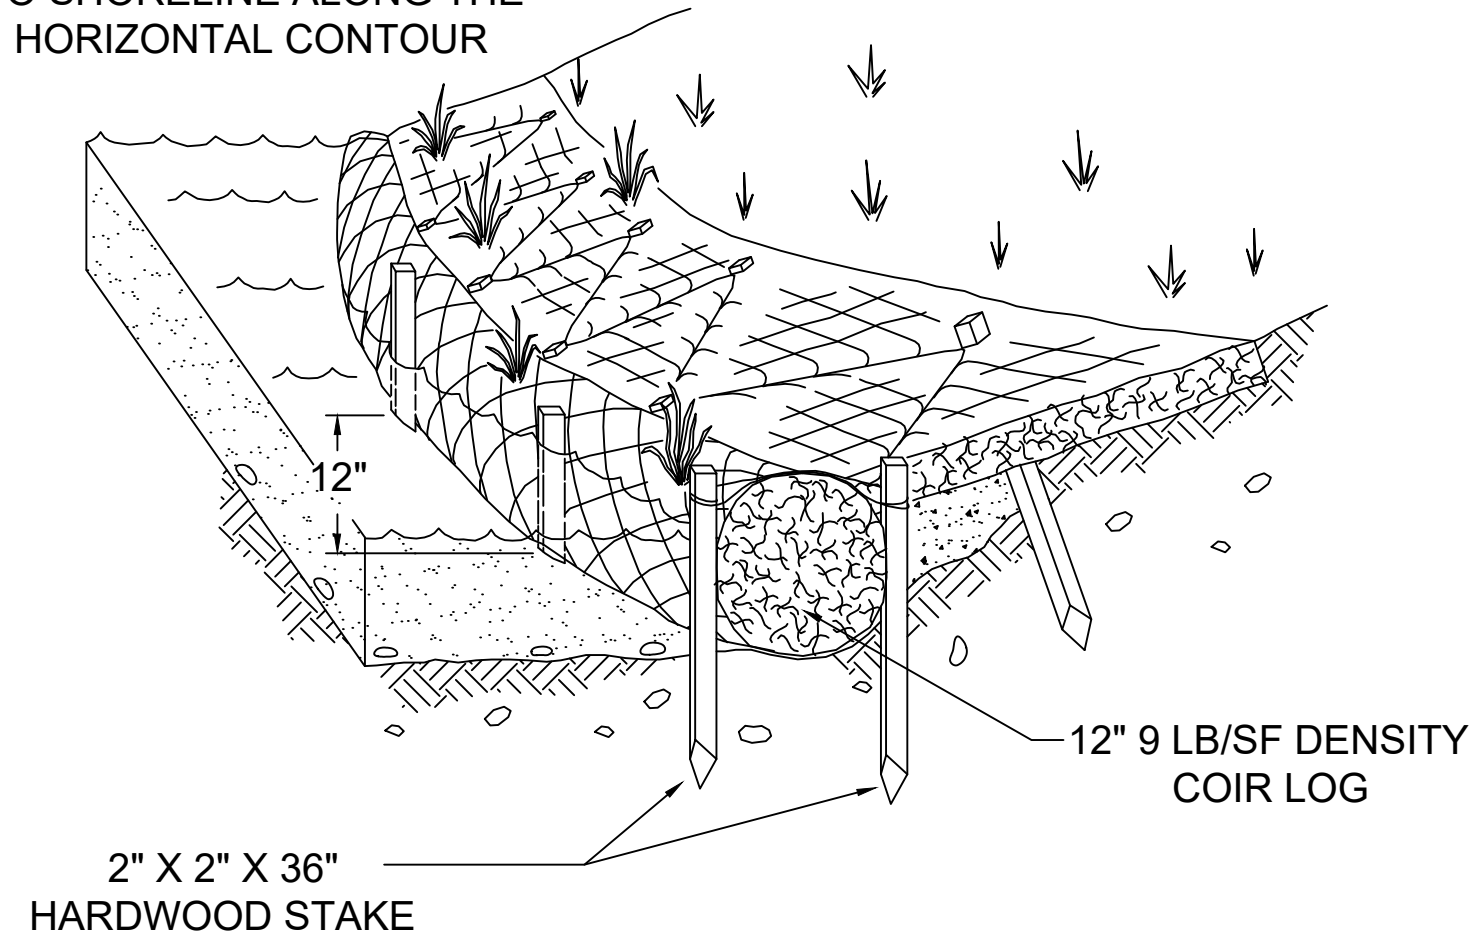
TYPICAL COIR LOG DETAIL

PLACE COIR LOGS PARALLEL TO SHORELINE ALONG THE HORIZONTAL CONTOUR

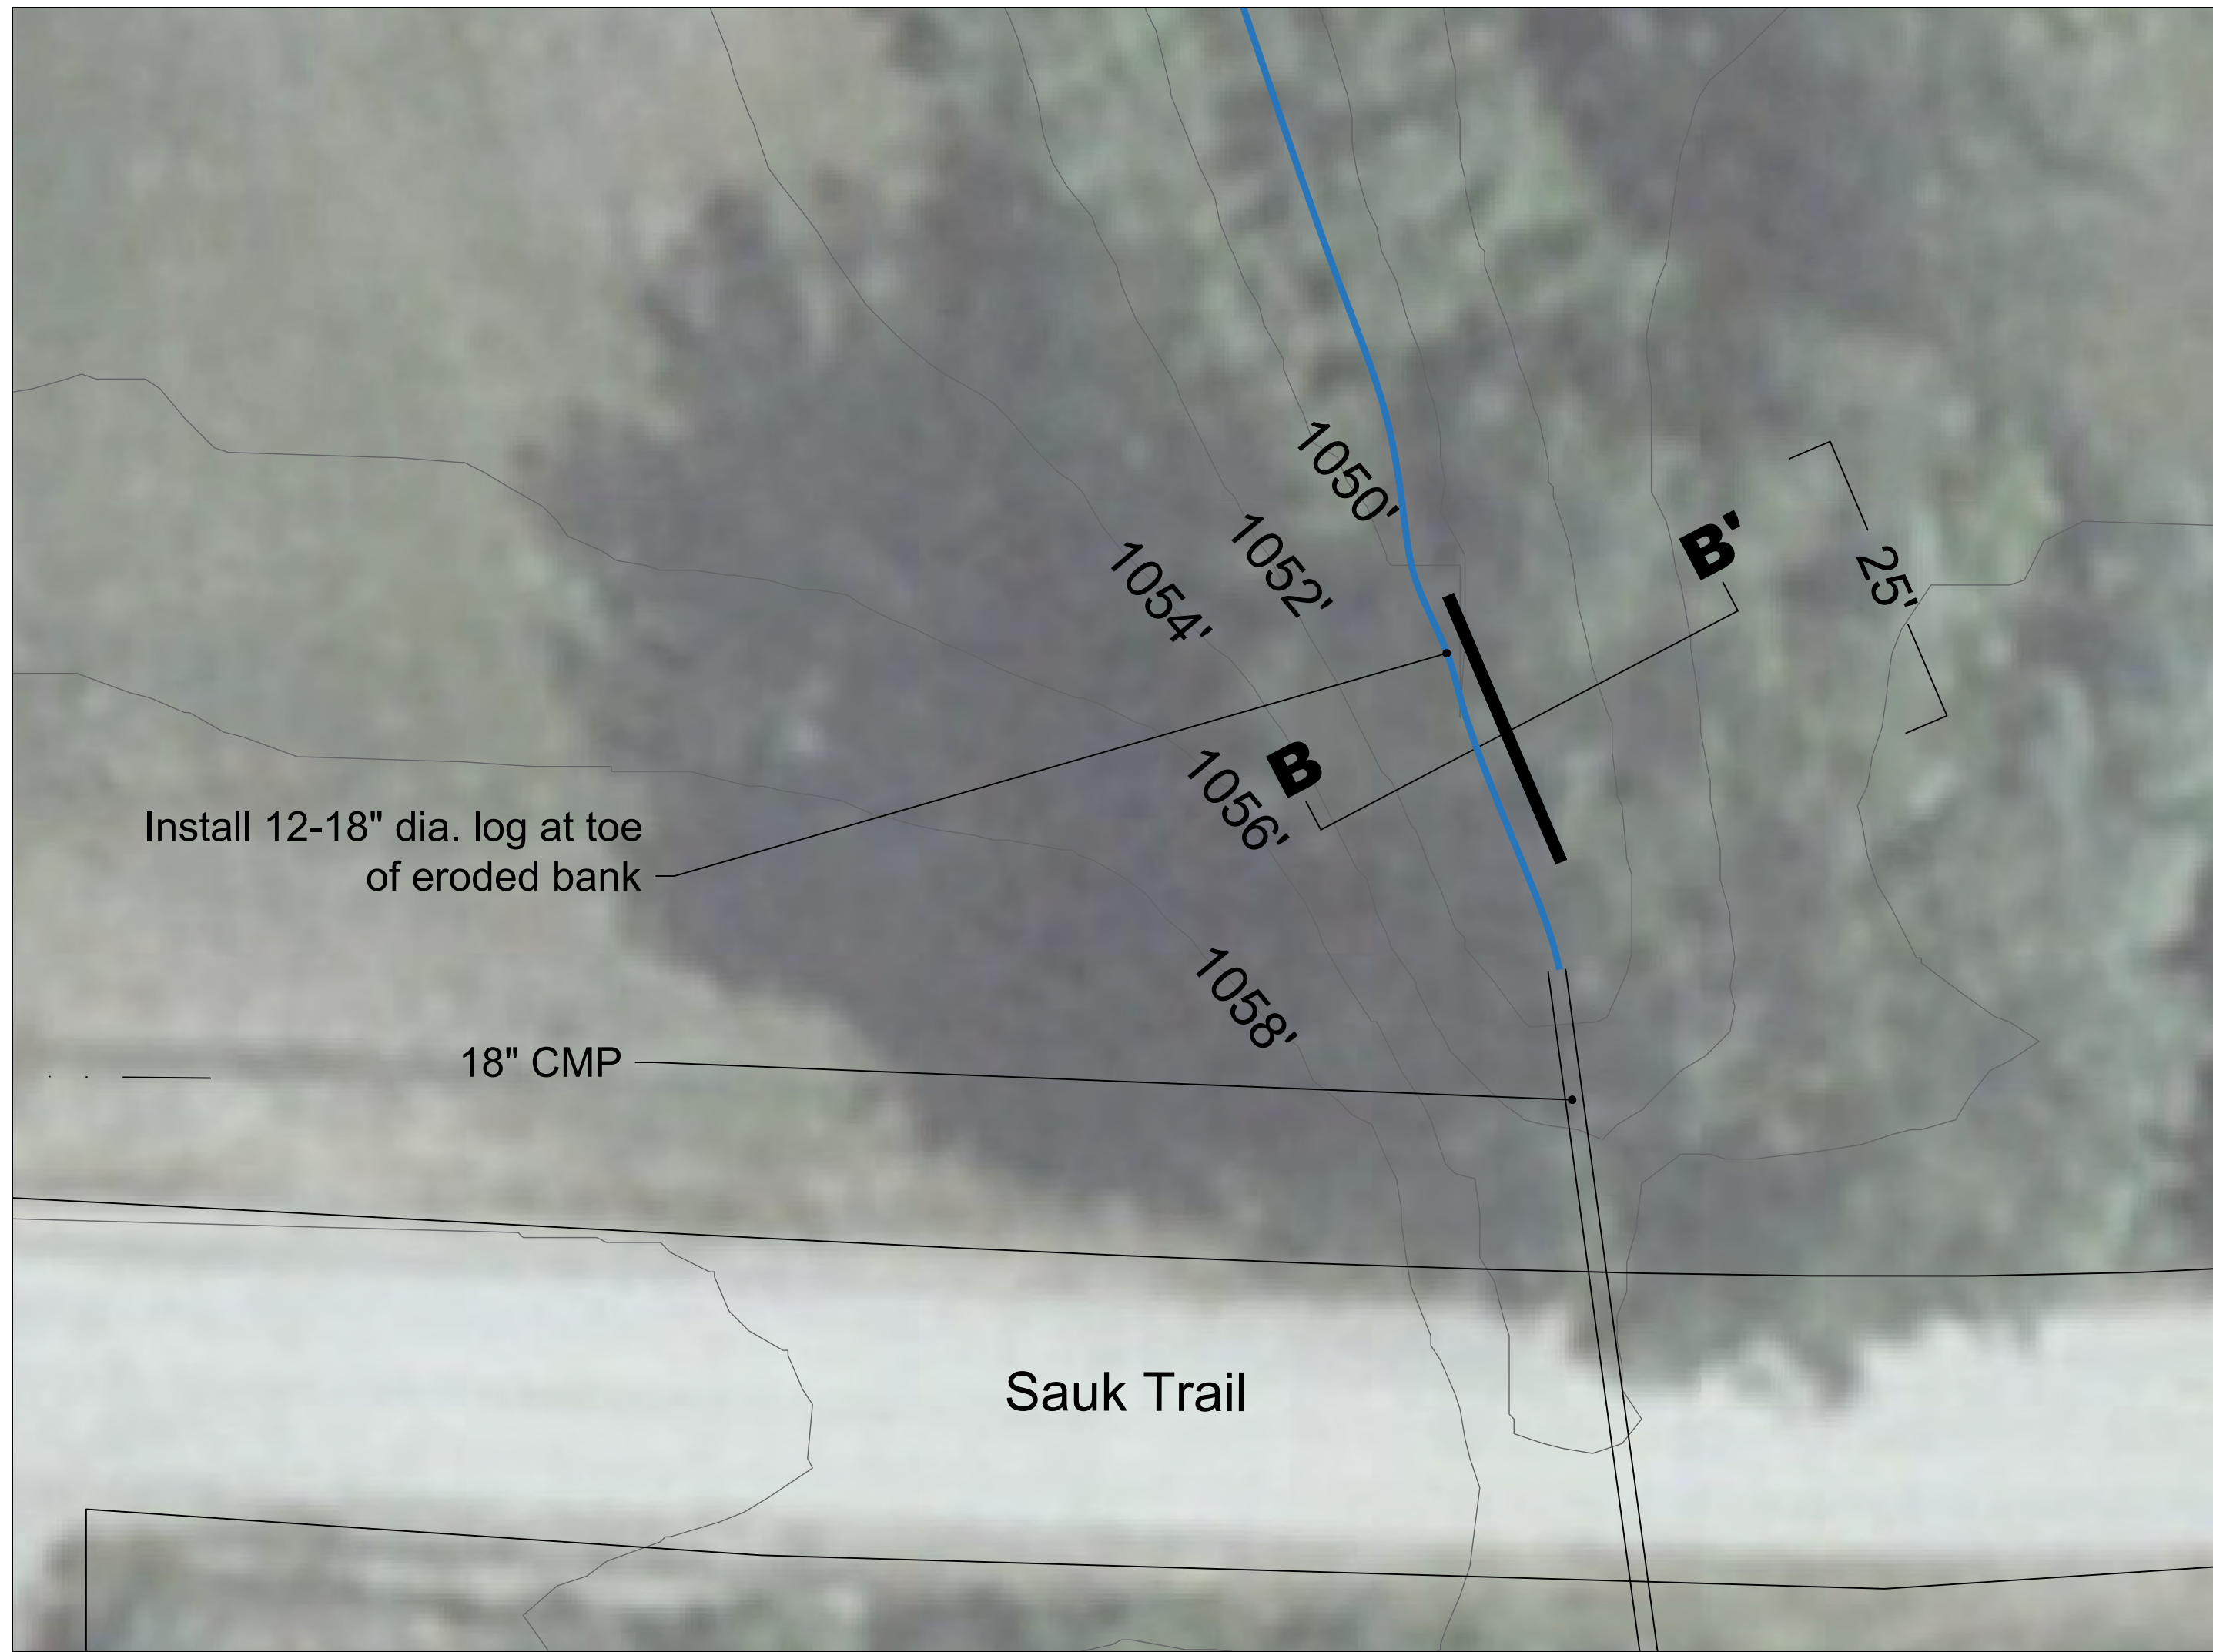
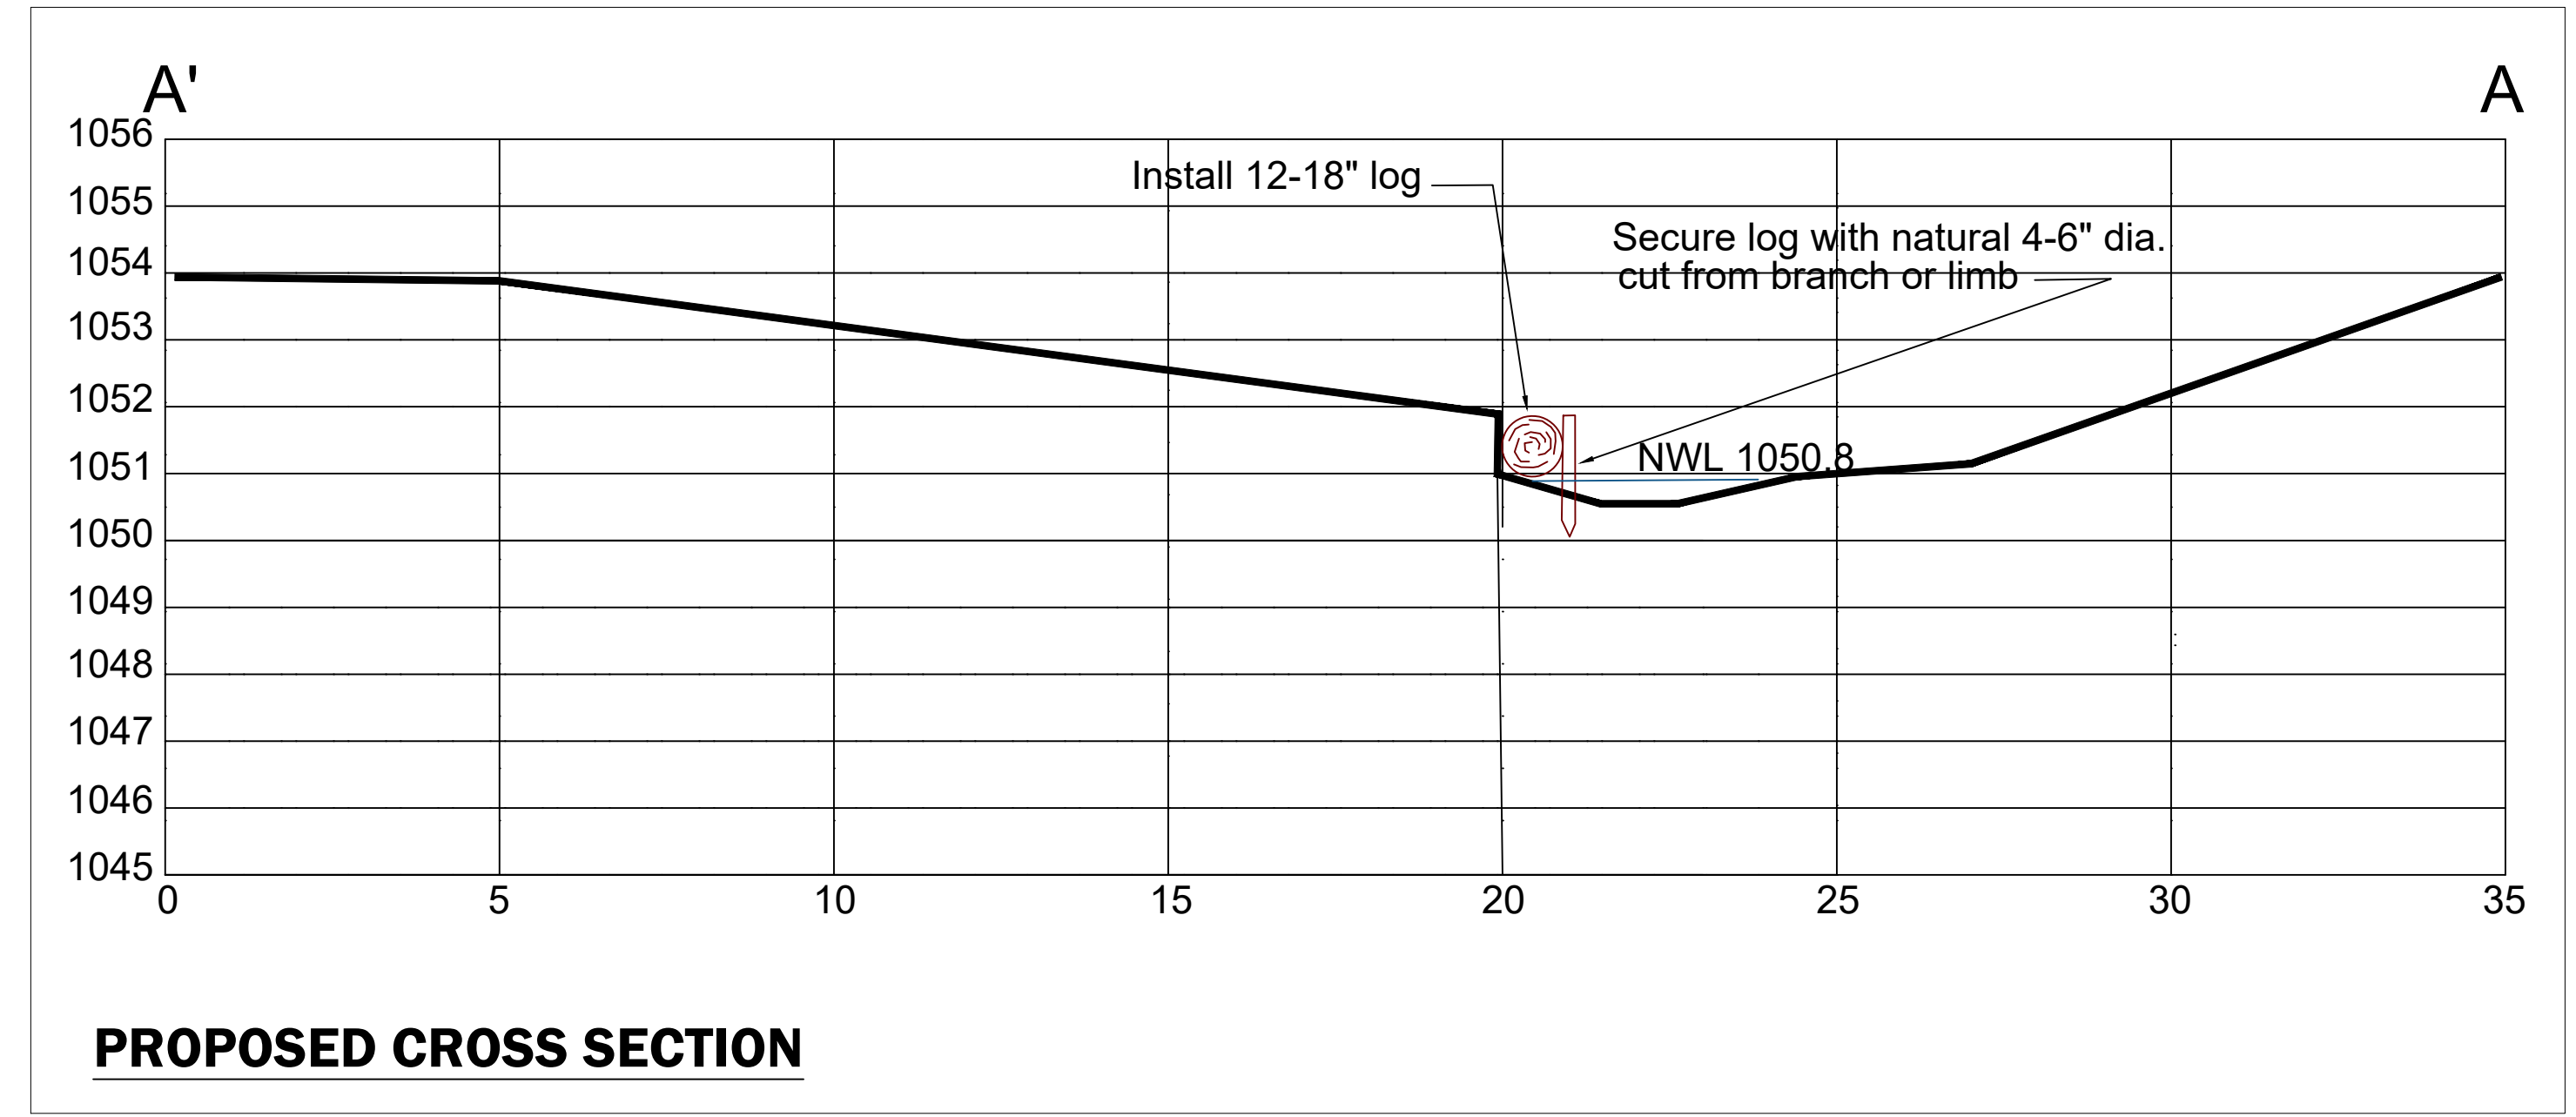
Lake LeAnn
Shoreline Management Plan
CSA 2A

PLAN VIEW
1"=40'
