Lake LeAnn Shoreline Management Plan

Lake LeAnn Property Owners Association
Hillsdale County, MI

December 2, 2020

Project: 2004639

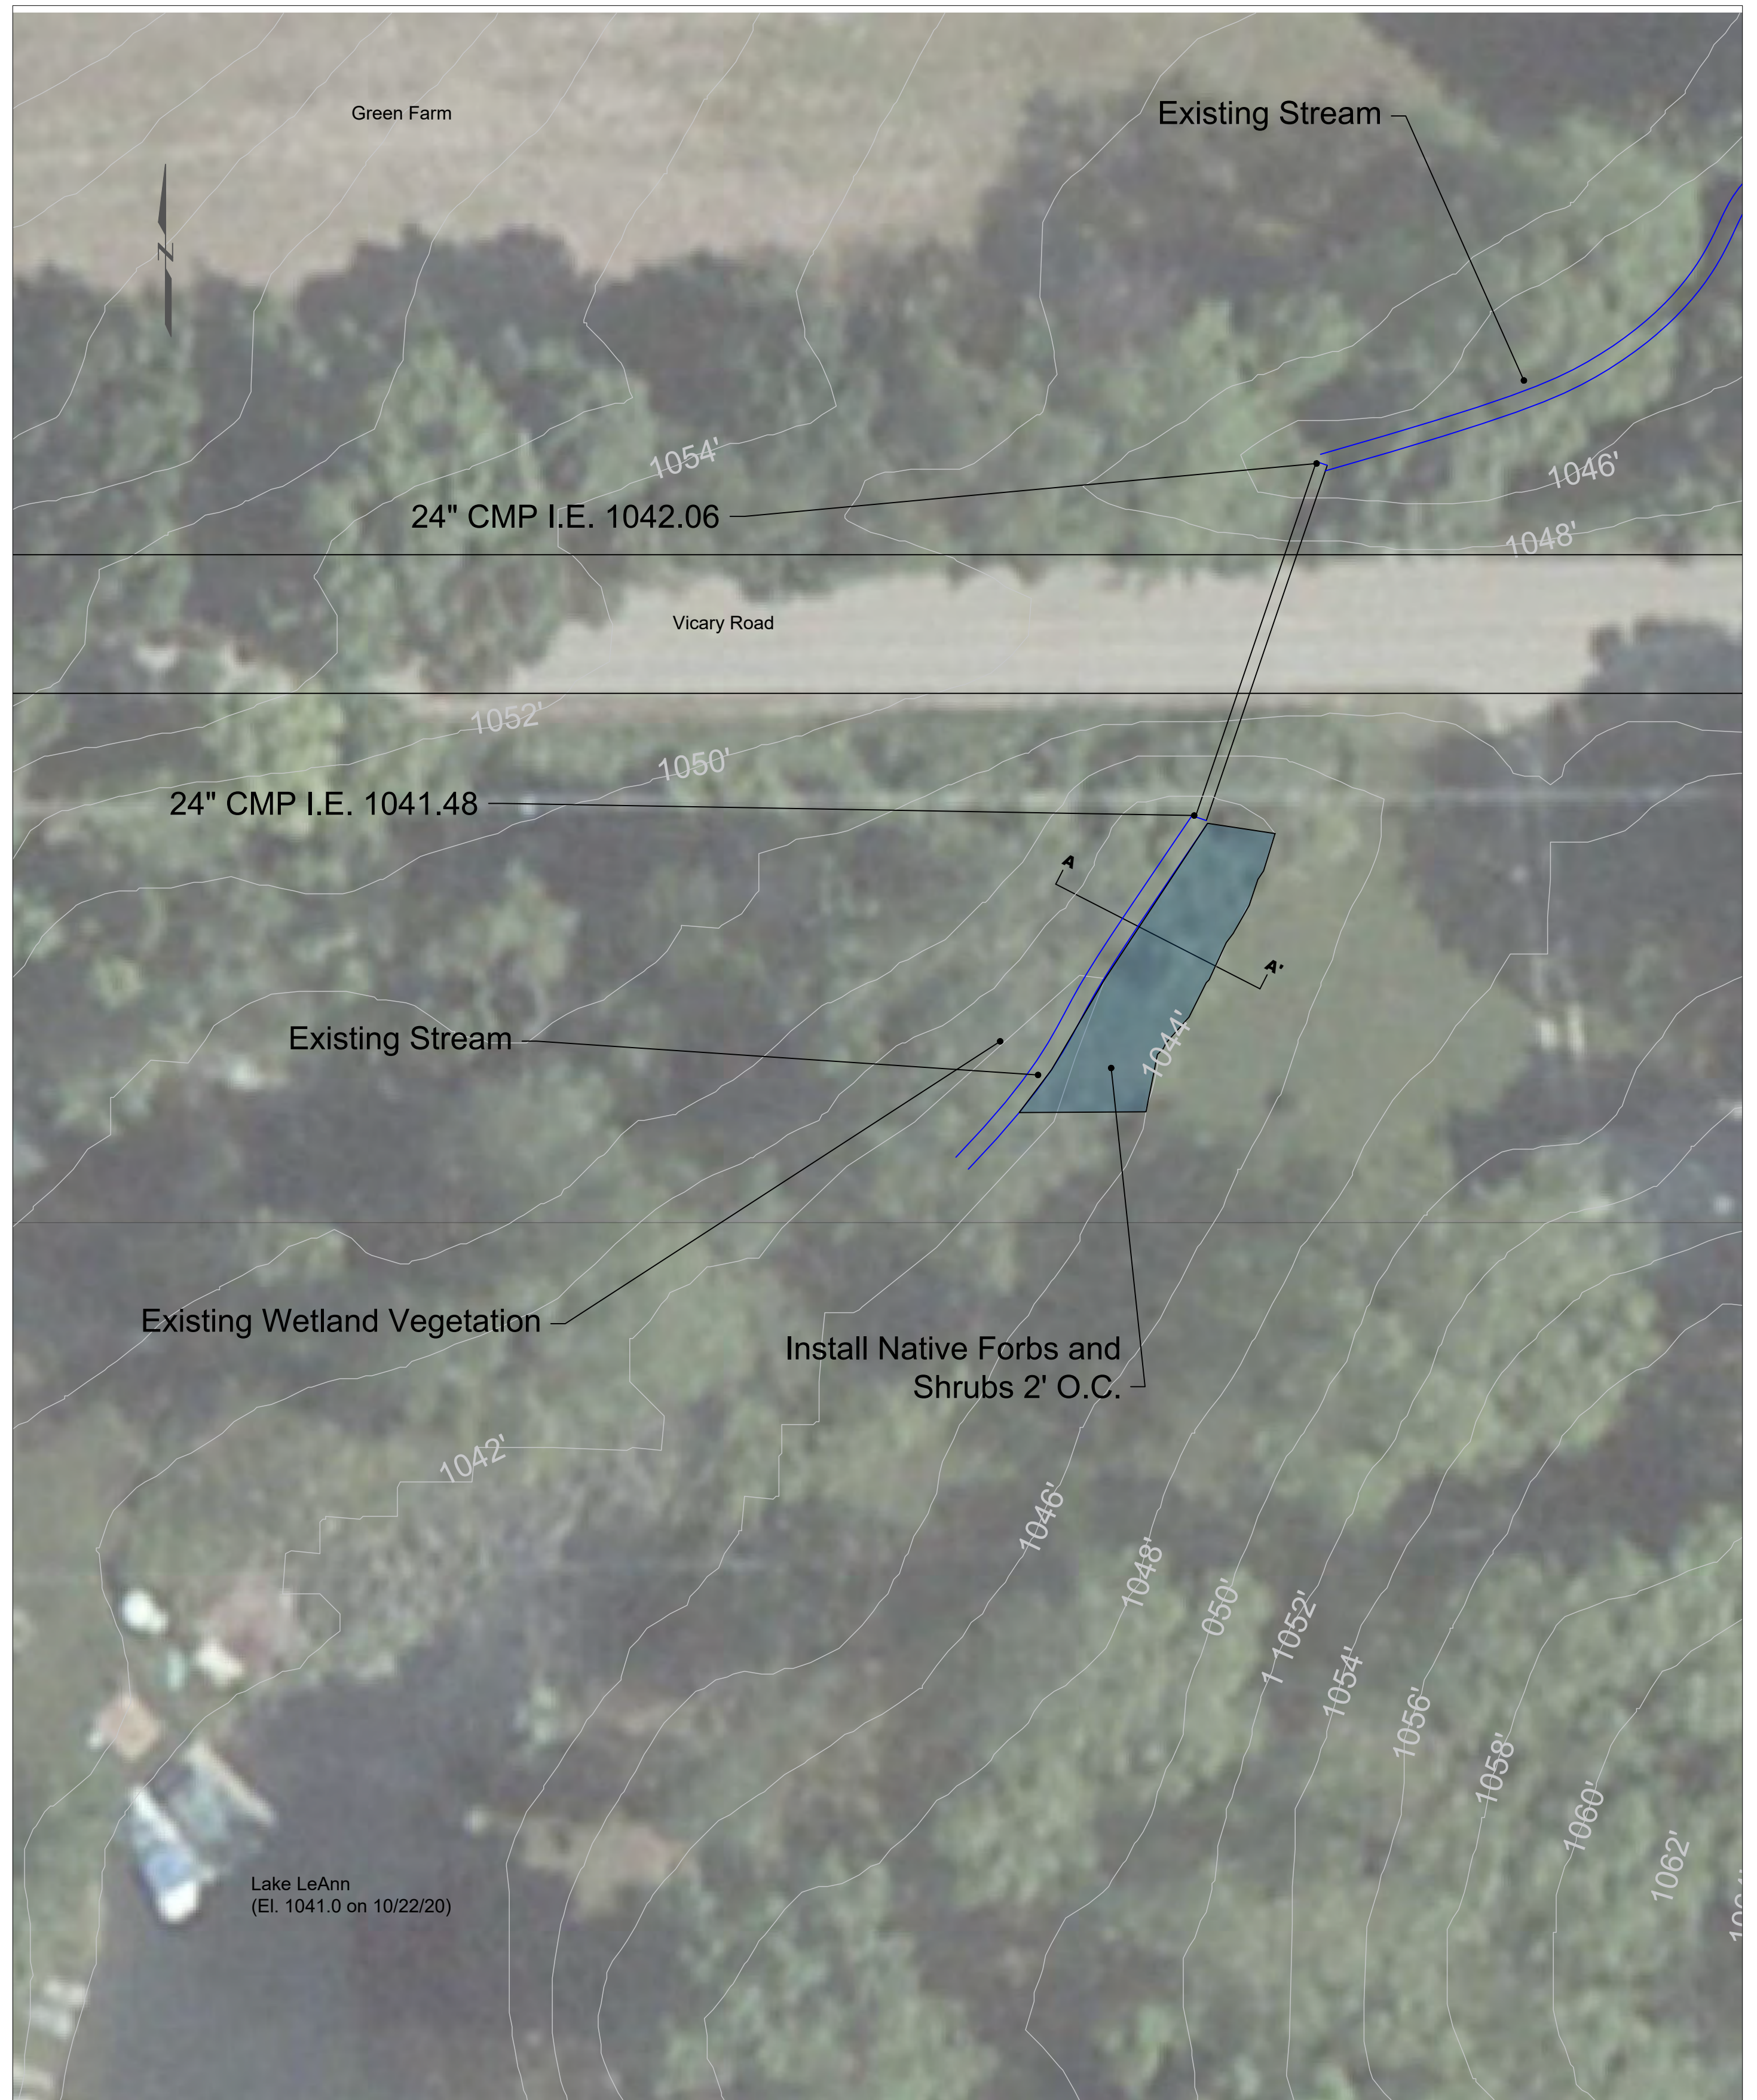
Lake LeAnn Shoreline Management Plan	DWG. NO. 7
CSA 2B	ISSUE

PLAN VIEW

Proposed actions for CSA 2b are to stabilize the eroding streambanks with bioengineering by incorporating large woody material along the streambank (Appendix C). Proposed actions for CSA 2a include the installation of an approximately 6,200 s.f. native plant buffer along the east shoreline. This area includes the culvert outlet and extends northward to the mooring sites. Restoration activities include turf removal through the application of an aquatic approved herbicide followed by installation of erosion control blanket (100% biodegradable), and 2,708 native plugs planted at a spacing of 1-1.5 ft. on center (detailed plans provided in Appendix C).

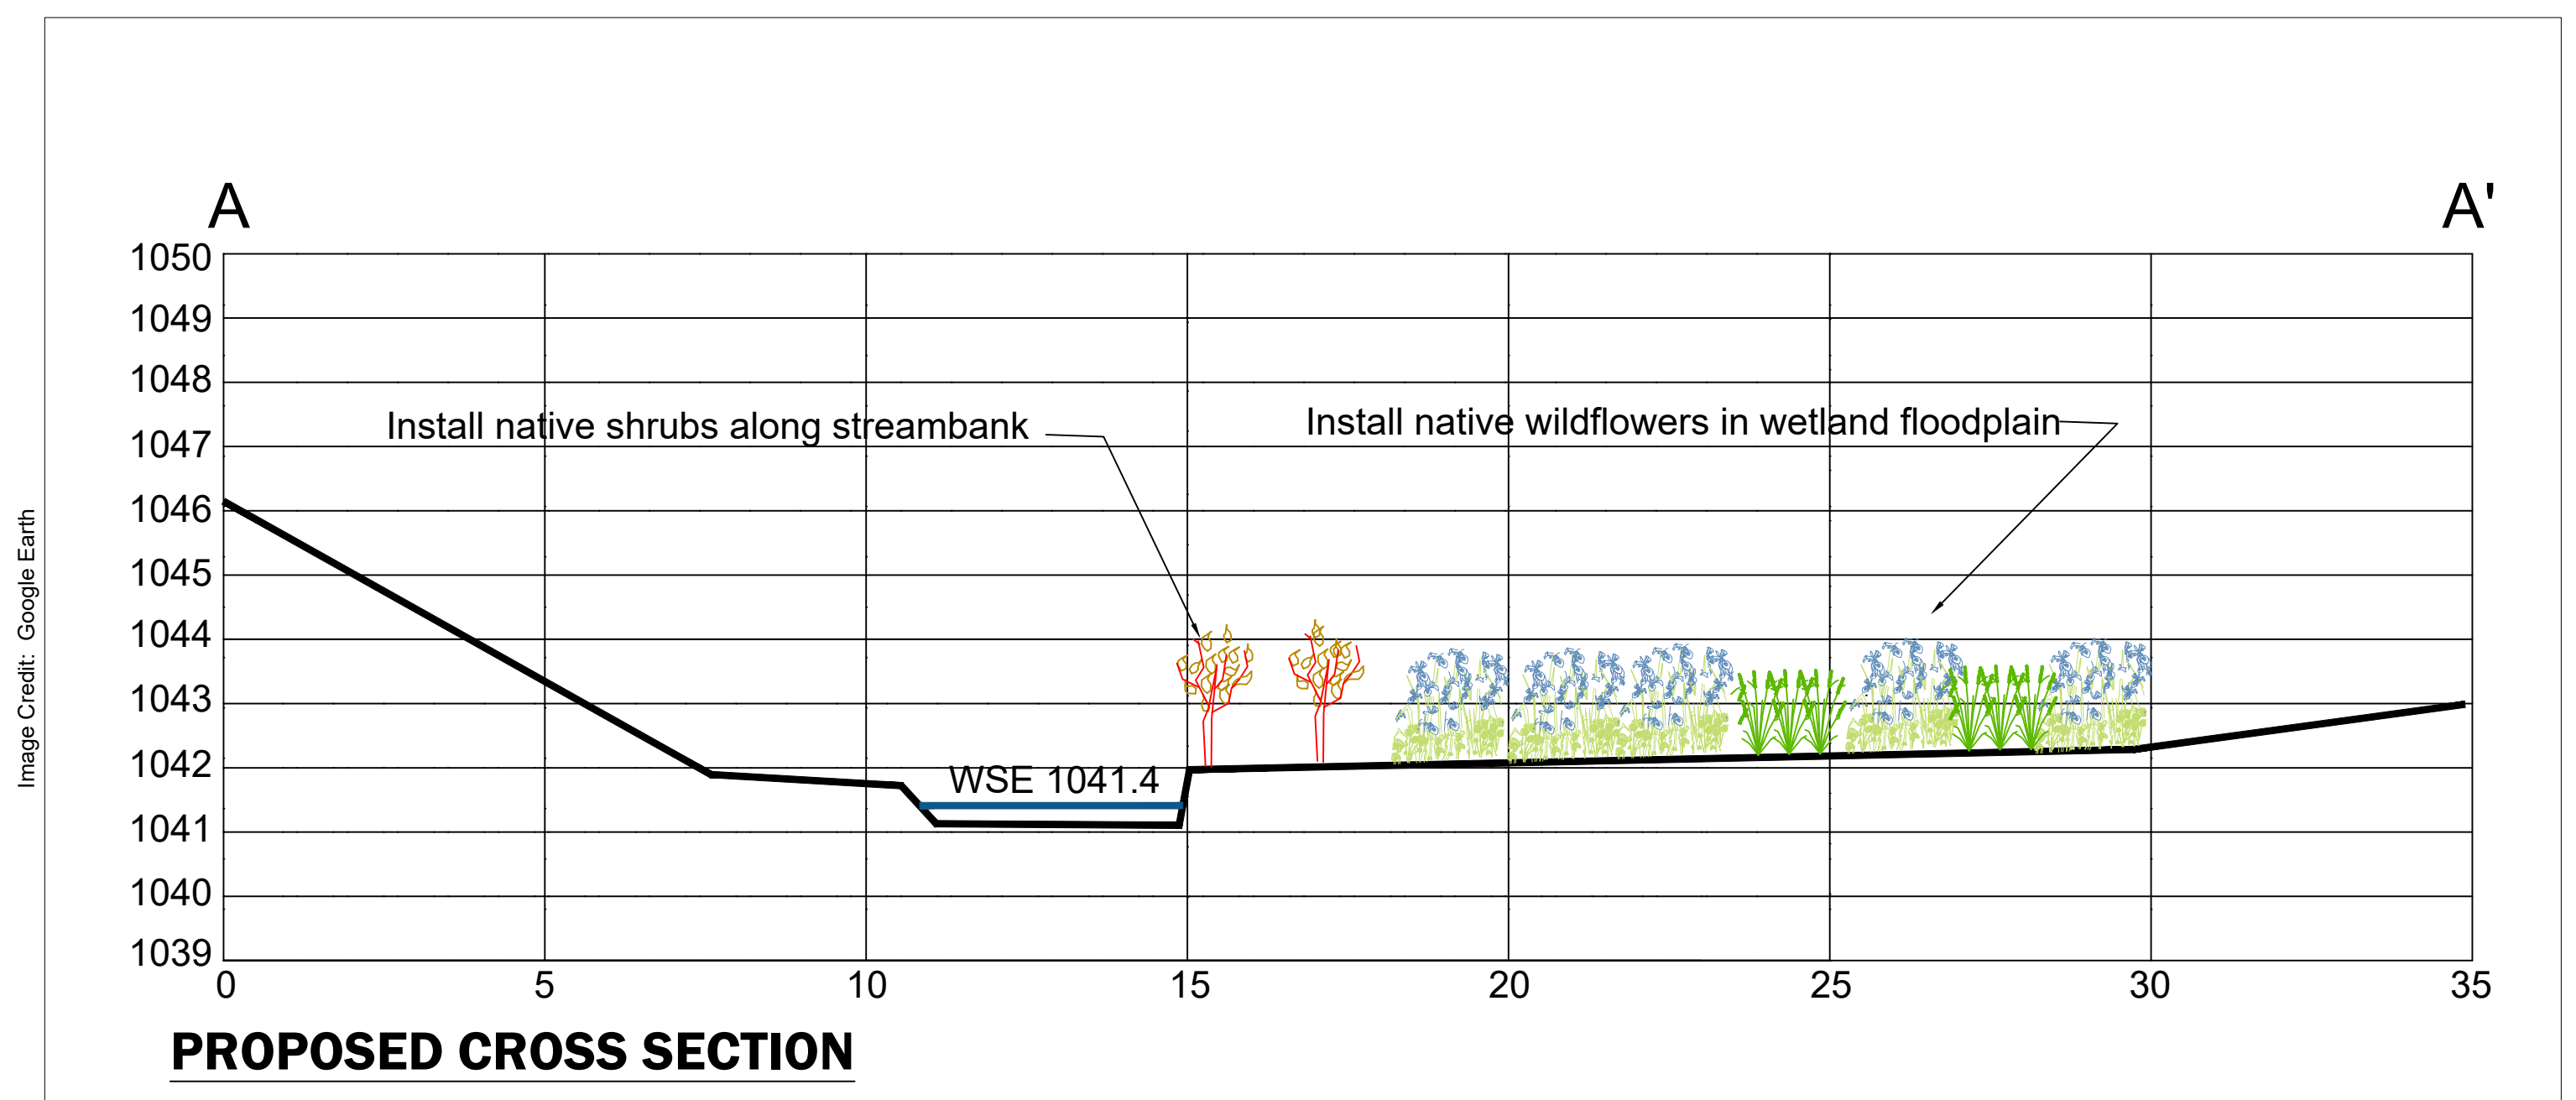
Lake LeAnn
 Shoreline Management Plan
 CSA 4

PROPOSED CROSS SECTION
