# **PART I. Lake LeAnn Improvement Study and Management Plan Hillsdale County, Michigan**

**Provided for: Lake LeAnn Property Owners Association (LLPOA) Board**

**Prepared by: Restorative Lake Sciences  
Jennifer L. Jermalowicz-Jones, PhD  
Water Resources Director  
18406 West Spring Lake Road  
Spring Lake, Michigan 49456  
[www.restorativelakesciences.com](http://www.restorativelakesciences.com)**

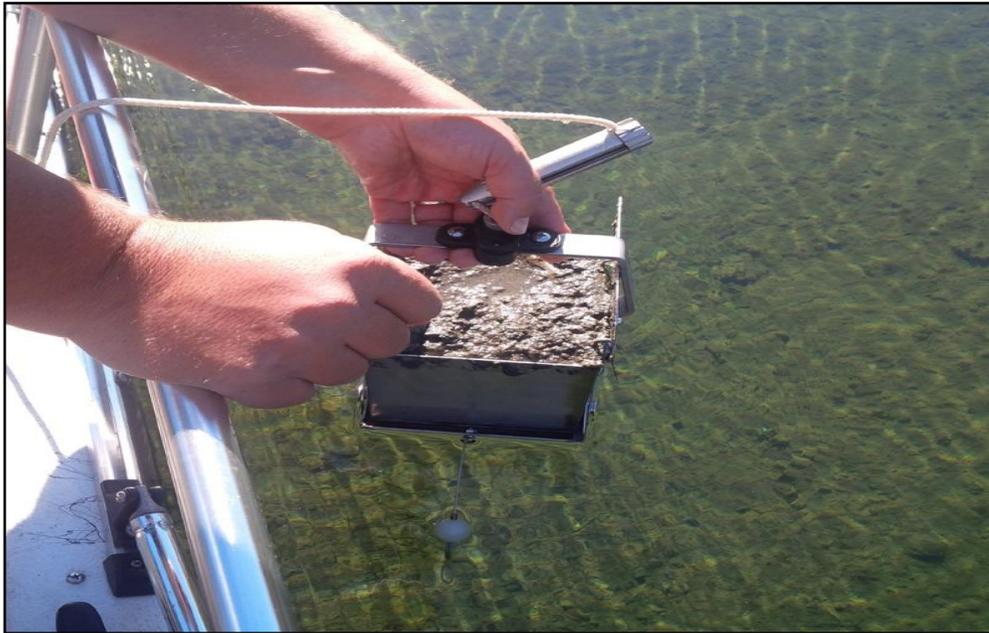
**Figure 45. An Ekman hand dredge for sampling lake sediments (RLS, 2018).**

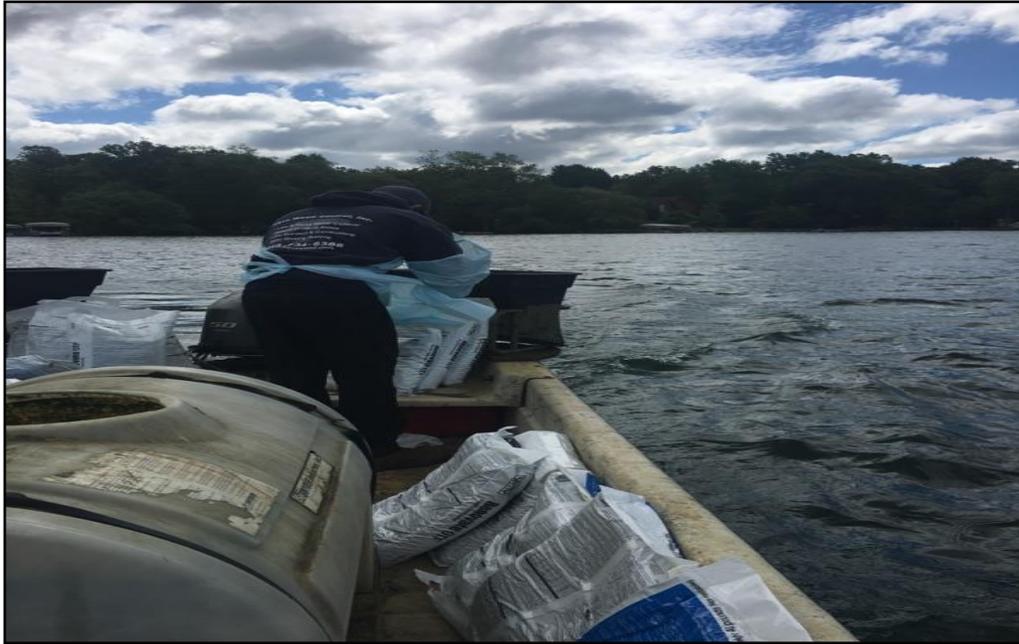
**Figure 52. A boat used to apply aquatic herbicides in inland lakes (RLS, 2018).**

The use of aquatic chemical herbicides is regulated by the Michigan Department of Natural Resources and requires a permit. Aquatic herbicides are generally applied via an airboat or skiff equipped with mixing tanks and drop hoses (Figure 52). The permit contains a list of approved herbicides for a particular body of water, as well as dosage rates, treatment areas, and water use restrictions. Contact and systemic aquatic herbicides are the two primary categories used in aquatic systems.

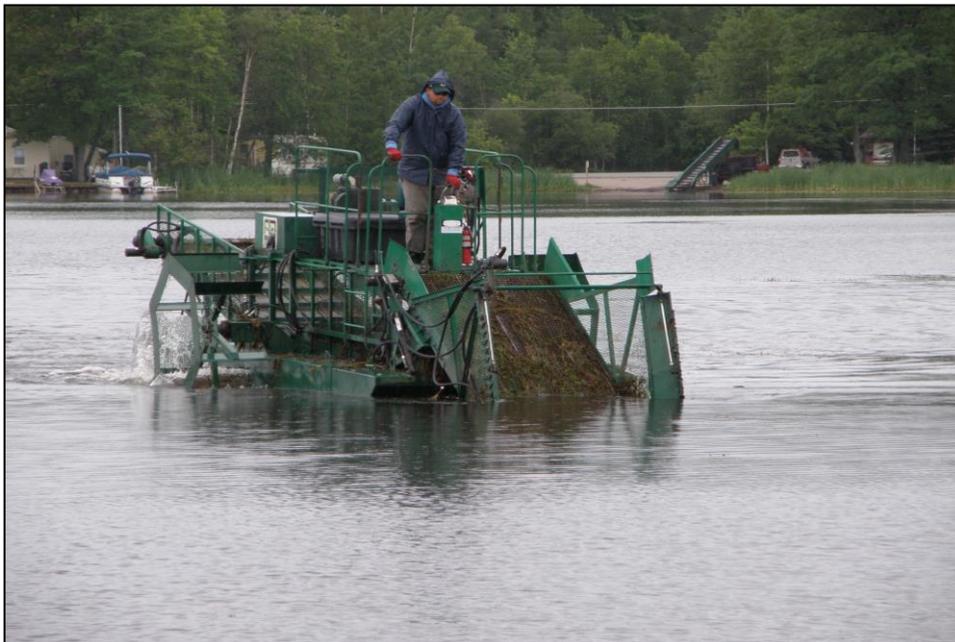
**Figure 54. A mechanical harvester used to remove aquatic plants (RLS, 2018).**

Mechanical harvesting is usually not recommended for the removal of Eurasian Watermilfoil since the plant may fragment when cut and re-grow on the lake bottom. It may be considered in future years for Lake LeAnn if the milfoil is not present and the residents desire a biomass removal technique that does not consist of the use of contact herbicides for nuisance pondweed removal.

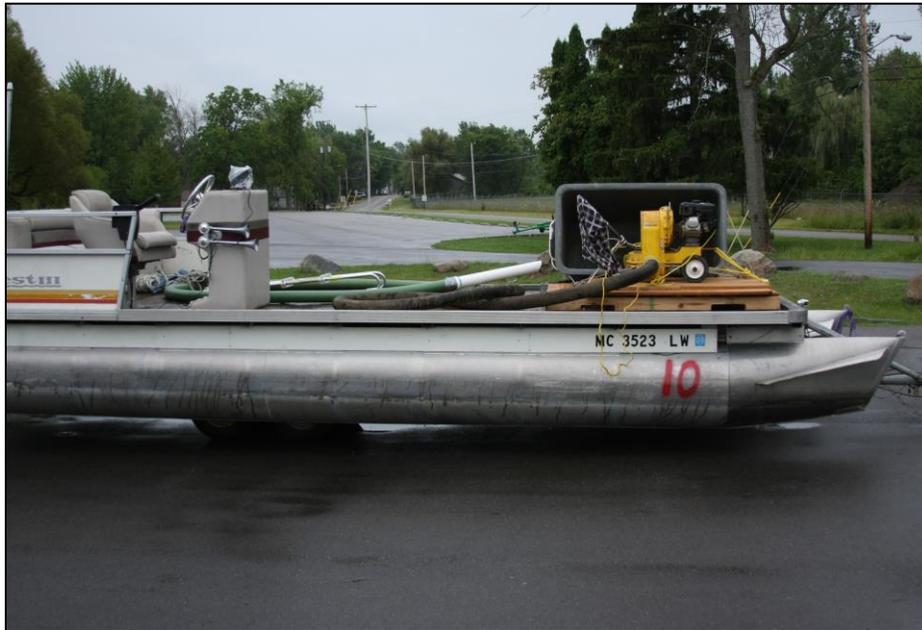
**Figure 57. A DASH boat used for aquatic plant removal (RLS, 2018).**

Furthermore, this activity may cause re-suspension of sediments (Nayar et al., 2007) which may lead to increased turbidity and reduced clarity of the water. This method is a sustainable option for removal of plant beds in beach areas and areas where herbicide treatments may be restricted.

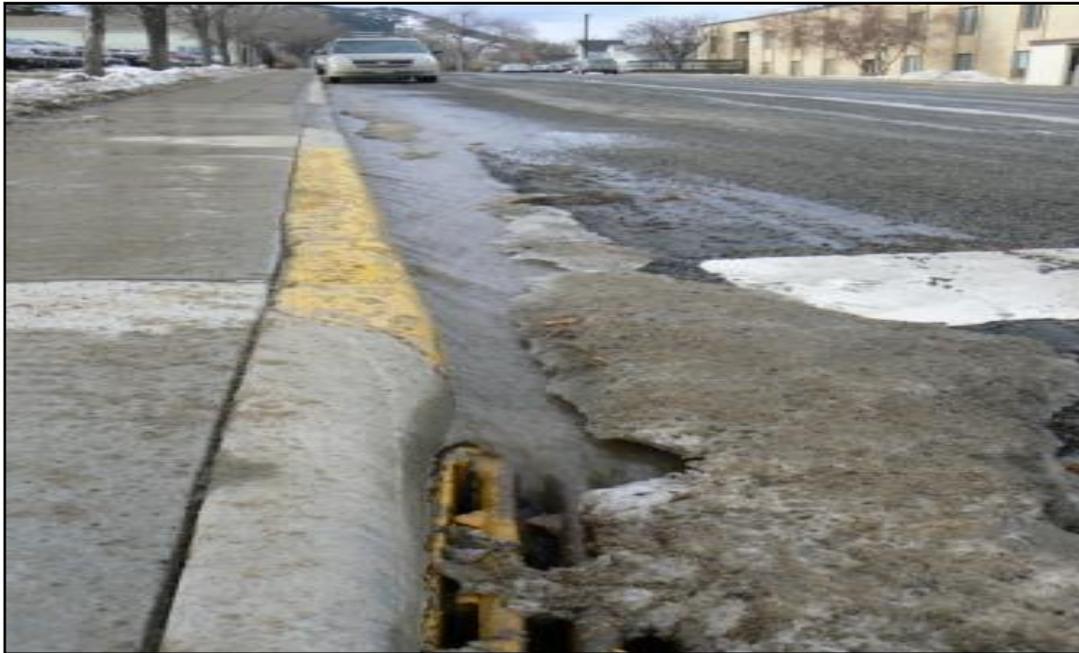
**Figure 2. A storm drain emptying a residential street that leads to a lake.**

Many types of land use activities can influence the watershed of a particular lake. Such activities include residential, industrial, agricultural, water supply, wastewater treatment, and storm water management land uses. Residential land use activities involve the use of lawn fertilizers on lakefront lawns, the utilization of septic tank systems for treatment of residential sewage, the construction of impervious (impermeable, hard-surfaced) surfaces on lands within the watershed (Figure 1), the burning of leaves near the lakeshore, the dumping of leaves or other pollutants into storm drains, and removal of vegetation from the land and near the water. In addition to residential land use activities, agricultural land practices by vegetable crop and cattle farmers may contribute nutrient loads to lakes and streams through erosion or runoff. All land uses may contribute to the water quality of the lake through the influx of pollutants from non-point sources (NPS) or from point sources. Non-point sources are often diffuse and arise when climatic events carry pollutants from the land into the lake. Point-source pollutants exit from pipes or input devices and empty directly into a lake or watercourse (Figure 2).

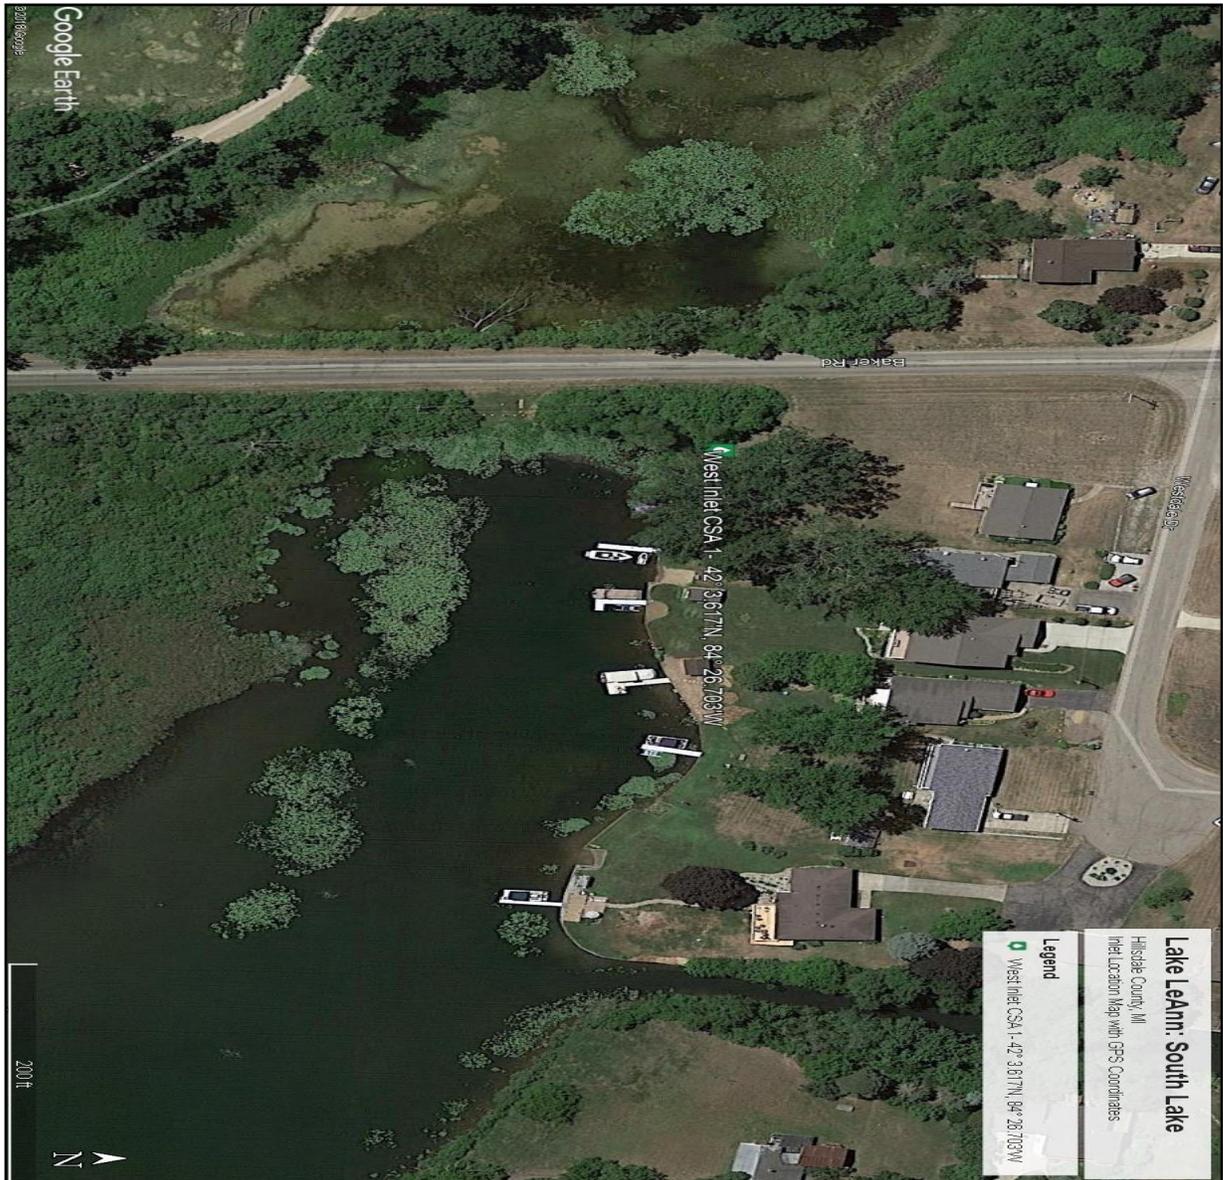
Figure 11. CSA #1 on the south basin of Lake LeAnn (RLS, 2019).

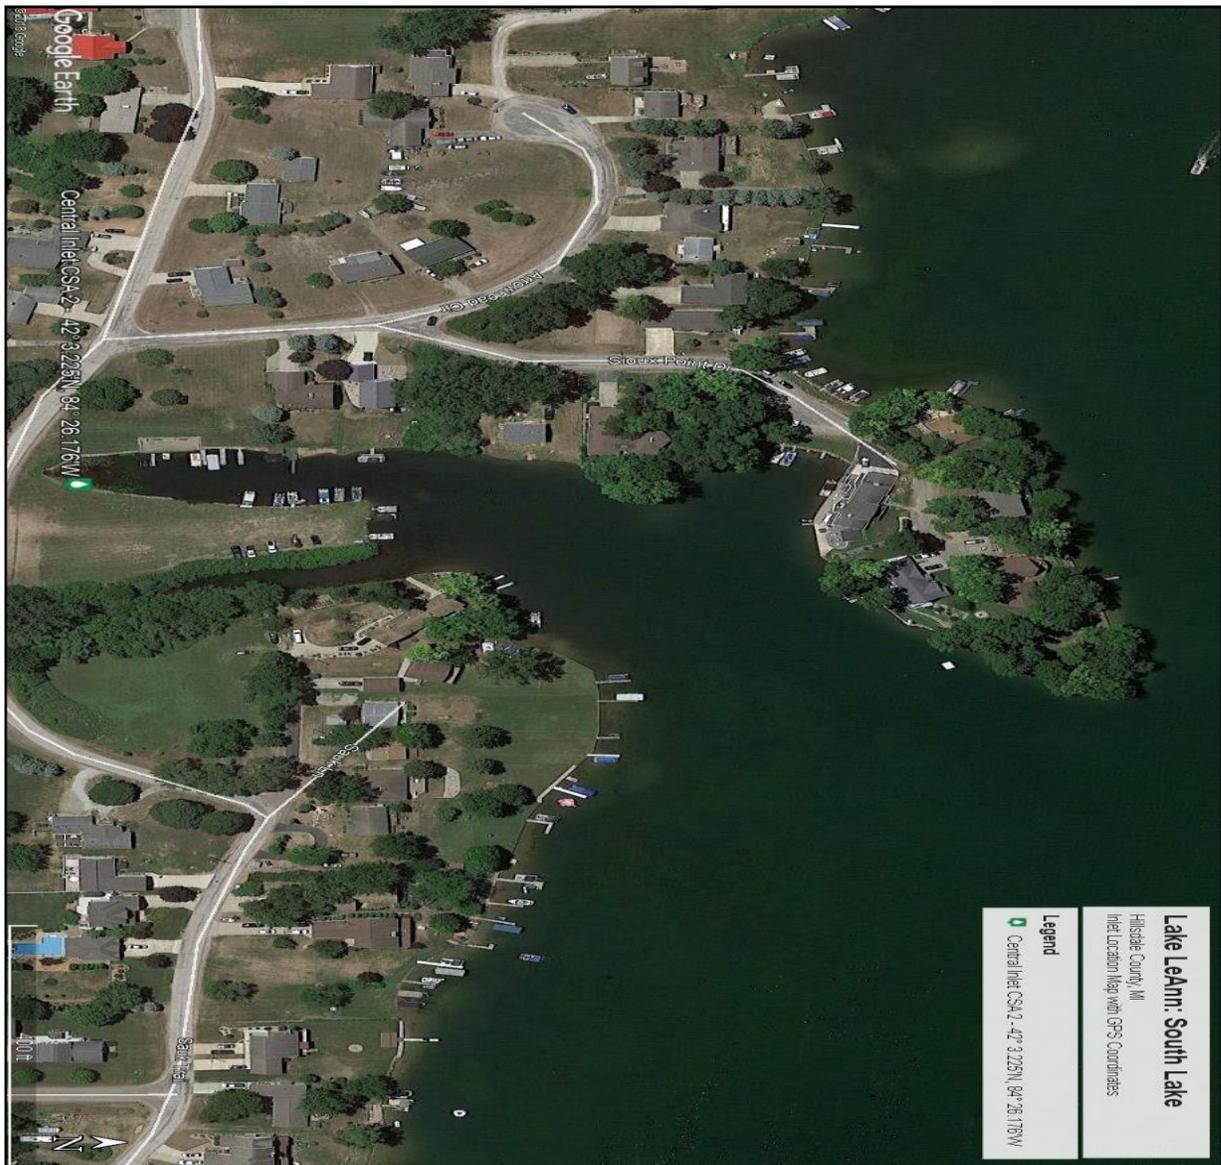
Figure 12. CSA #2 Central Inlet in the south basin of Lake LeAnn (RLS, 2019).

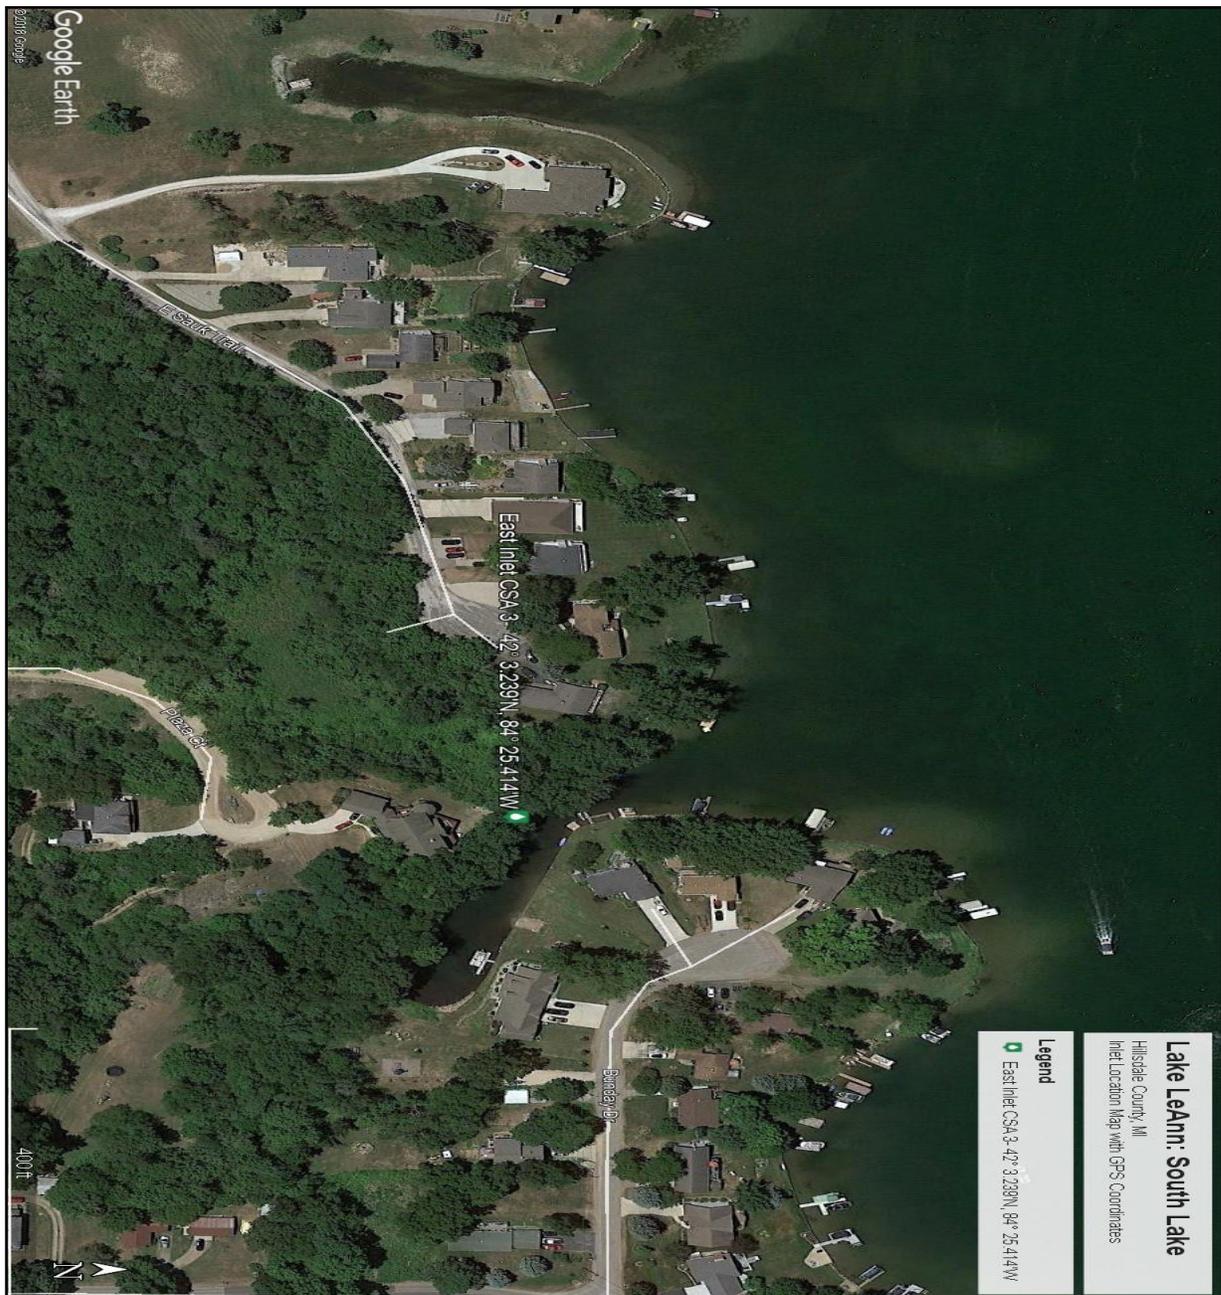
Figure 13. CSA #3 East Inlet on south basin of Lake LeAnn (RLS, 2019).

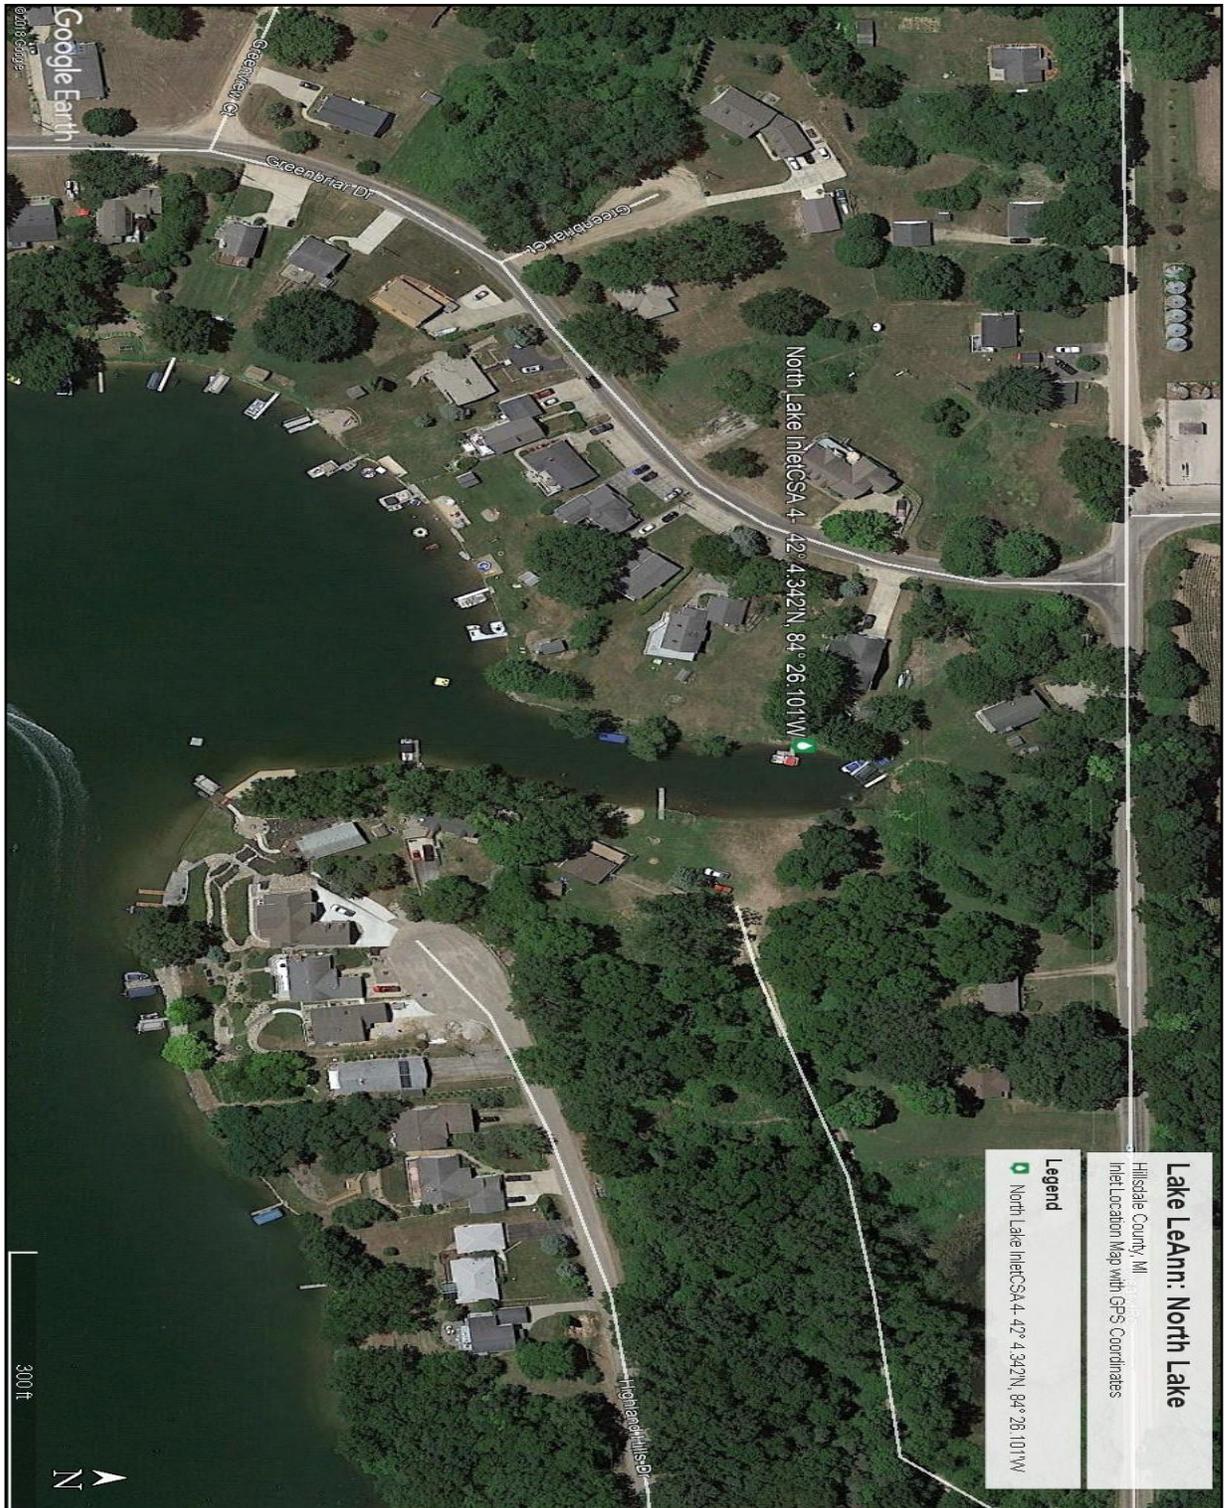
Figure 14. CSA #4 North Lake Inlet on the north basin of Lake LeAnn (RLS, 2019).

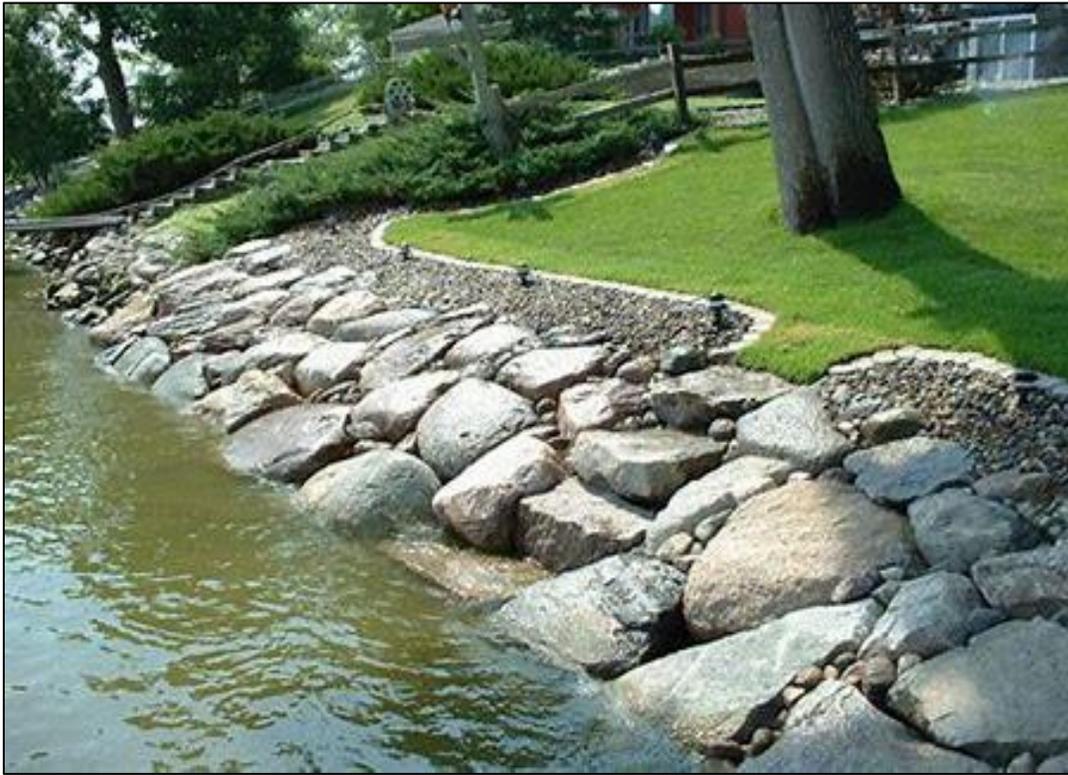
Figure 28. Example of armored protection/riprap.

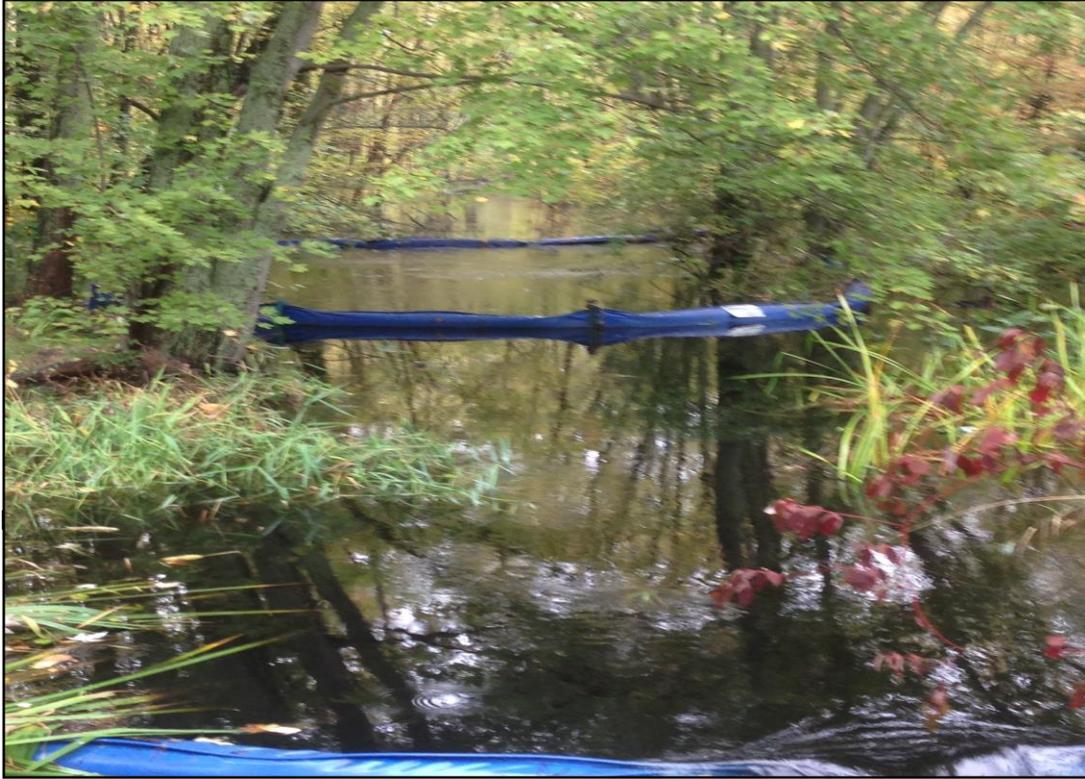
Figure 30. Example of a tributary/drain filter.
